Moores Creek, Lodge Creek, Meadow Creek, and Schenks Branch Sediment Total Maximum Daily Load (TMDL) Action Plan Permit Cycle: 2023-2028

General Permit No.: VAR040073

May 2025

University of Virginia Environmental Resources
1490 Leake Drive, Charlottesville, VA 22904

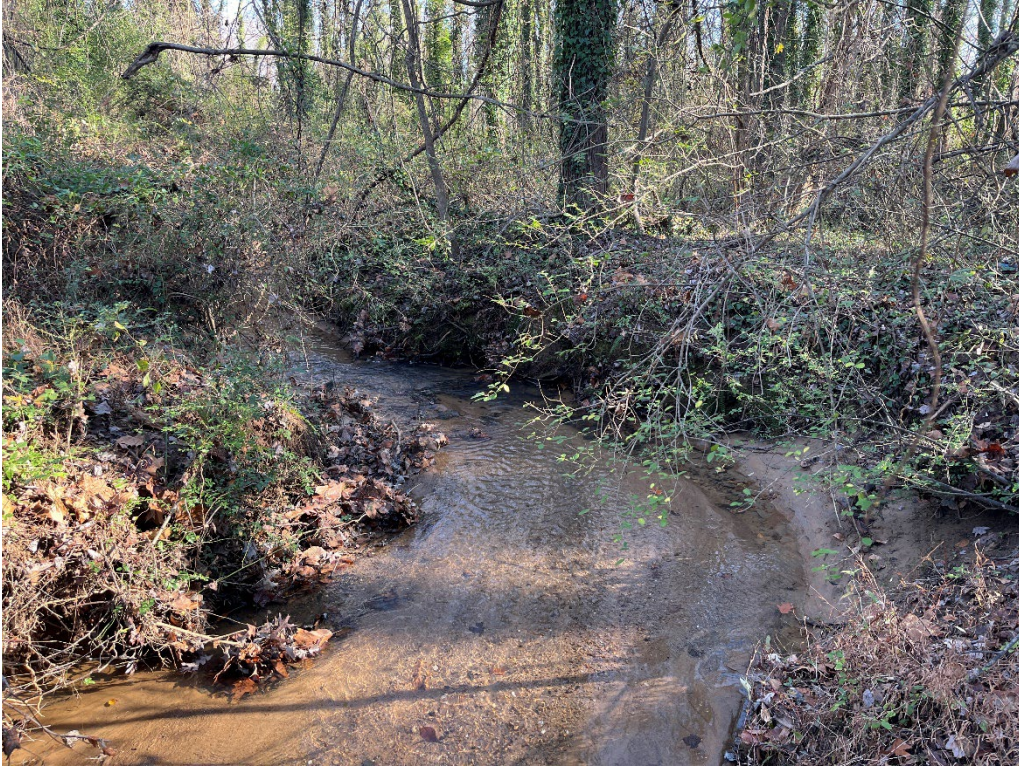
Reach 6 - This 900-foot reach is on the main tributary which traverses the site. It is generally bound by the dam embankment at the upstream end and a Rivanna Trail walking bridge at the downstream end of the reach. It is characterized by a moderately incised channel with near vertical, eroding banks. Riparian vegetation is in poor condition with widespread invasive species throughout the adjacent riparian area (Photo 6).

Photo 6: Moderately eroded banks and invasive vegetation present throughout Reach 6.

- Reach 6 - This portion of the main channel below the pond embankment to the first Rivanna Trail walking bridge could be restored in a similar manner to Reach 4 with a series rock and large woody debris grade control structures in the existing channel (see example Photo 15 below). The channel bed could be raised to provide low banks and enhanced connection with the adjacent floodplain. This reach also has low quality riparian vegetation with widespread presence of invasive species. The restoration in this area should include invasive treatments and maintained establishment of native riparian vegetation. The installation of the grade control structures and increase in bank stability will result in

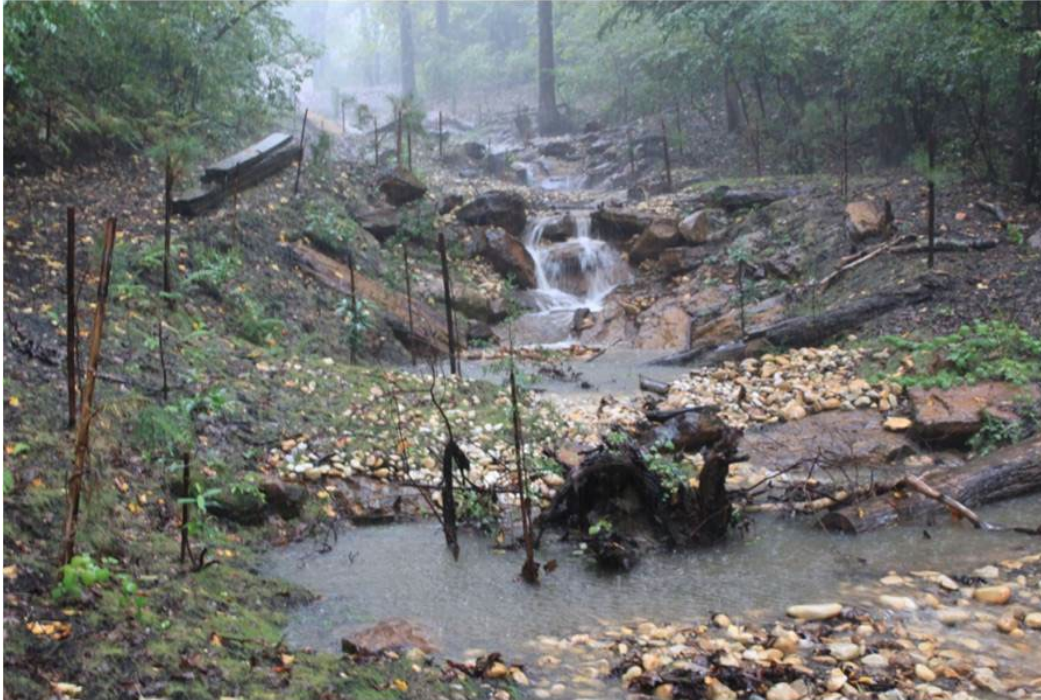
- Reach 2 - This outfall channel could be stabilized with boulder cascade grade controls in the existing channel to prevent further erosion due to headcutting (see example Photo 11 below). This would likely require the installation of 2-4 boulder cascades in or around the existing headcut locations. These grade controls would prevent significant vertical downcutting and associated channel erosion. It is anticipated that the Chesapeake Bay Program Protocol 5 – Crediting Outfall and Gully Stabilization Projects would apply to work on this tributary. This reach is the second furthest from the anticipated access location near via the Rivanna Trail segment, which may influence the cost-benefit analysis of including outfall in the proposed work. Access would be relatively simple if VDOT allowed access from the Route 29/250 Bypass.

Photo 11: Example of boulder cascade channel stabilization.

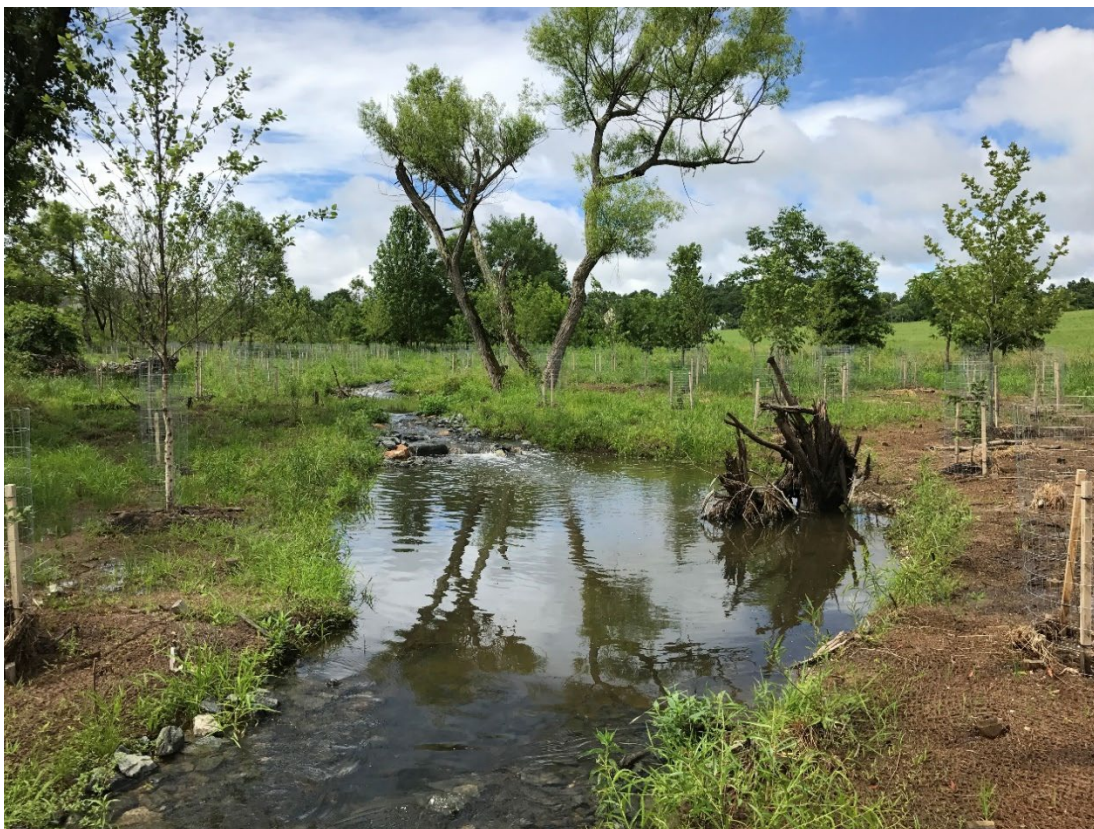
- Reach 8 – Alt 2 - This portion of the main channel could be restored by creating a new stable channel alignment using Natural Channel Design techniques (see example Photo 16 below). Available floodplain area and poor-quality riparian vegetation in this area make it the best candidate of all the reaches for channel relocation. The relocated channel will be designed for more frequent connection with the adjacent floodplain, stable planform geometry, and stable grade controls at transitions between meander bends. This reach also has low quality riparian vegetation with widespread presence of invasive species. The restoration in this area should include invasive treatments and maintained establishment of native riparian vegetation. The new stable channel design will increase bank stability and will result in significantly less channel erosion potential. Raising the channel bed will increase hyporheic flow and increase nutrient capture as well as providing a more frequent connection with the adjacent floodplain to reduce erosive forces on the channel and deposit nutrients on the floodplain. This restoration approach will require some short-term impacts to aquatic habitat, but these impacts will be outweighed by the long-term benefits of re-establishing a more stable channel with improved aquatic habitat and reconnection with the adjacent floodplain. It is anticipated that the Chesapeake Bay Program Protocol 1 –Credit for Prevented Sediment during Storm Flow and Protocol 2 – Credit for Instream and Riparian Nutrient Processing during Baseflow would apply to work on this reach of the main channel. Protocol 3 – Credit for Floodplain Reconnection Volume may apply to work on this reach of the main channel, but it is not included in preliminary load reduction computations due required modeling to be completed in detailed design phases. It is assumed that construction access to this reach would result in temporary relocation of the Rivanna trail during removal of invasive species and construction activities.

Photo 15: Example of natural channel design channel with enhanced floodplain connection and large woody debris installations.

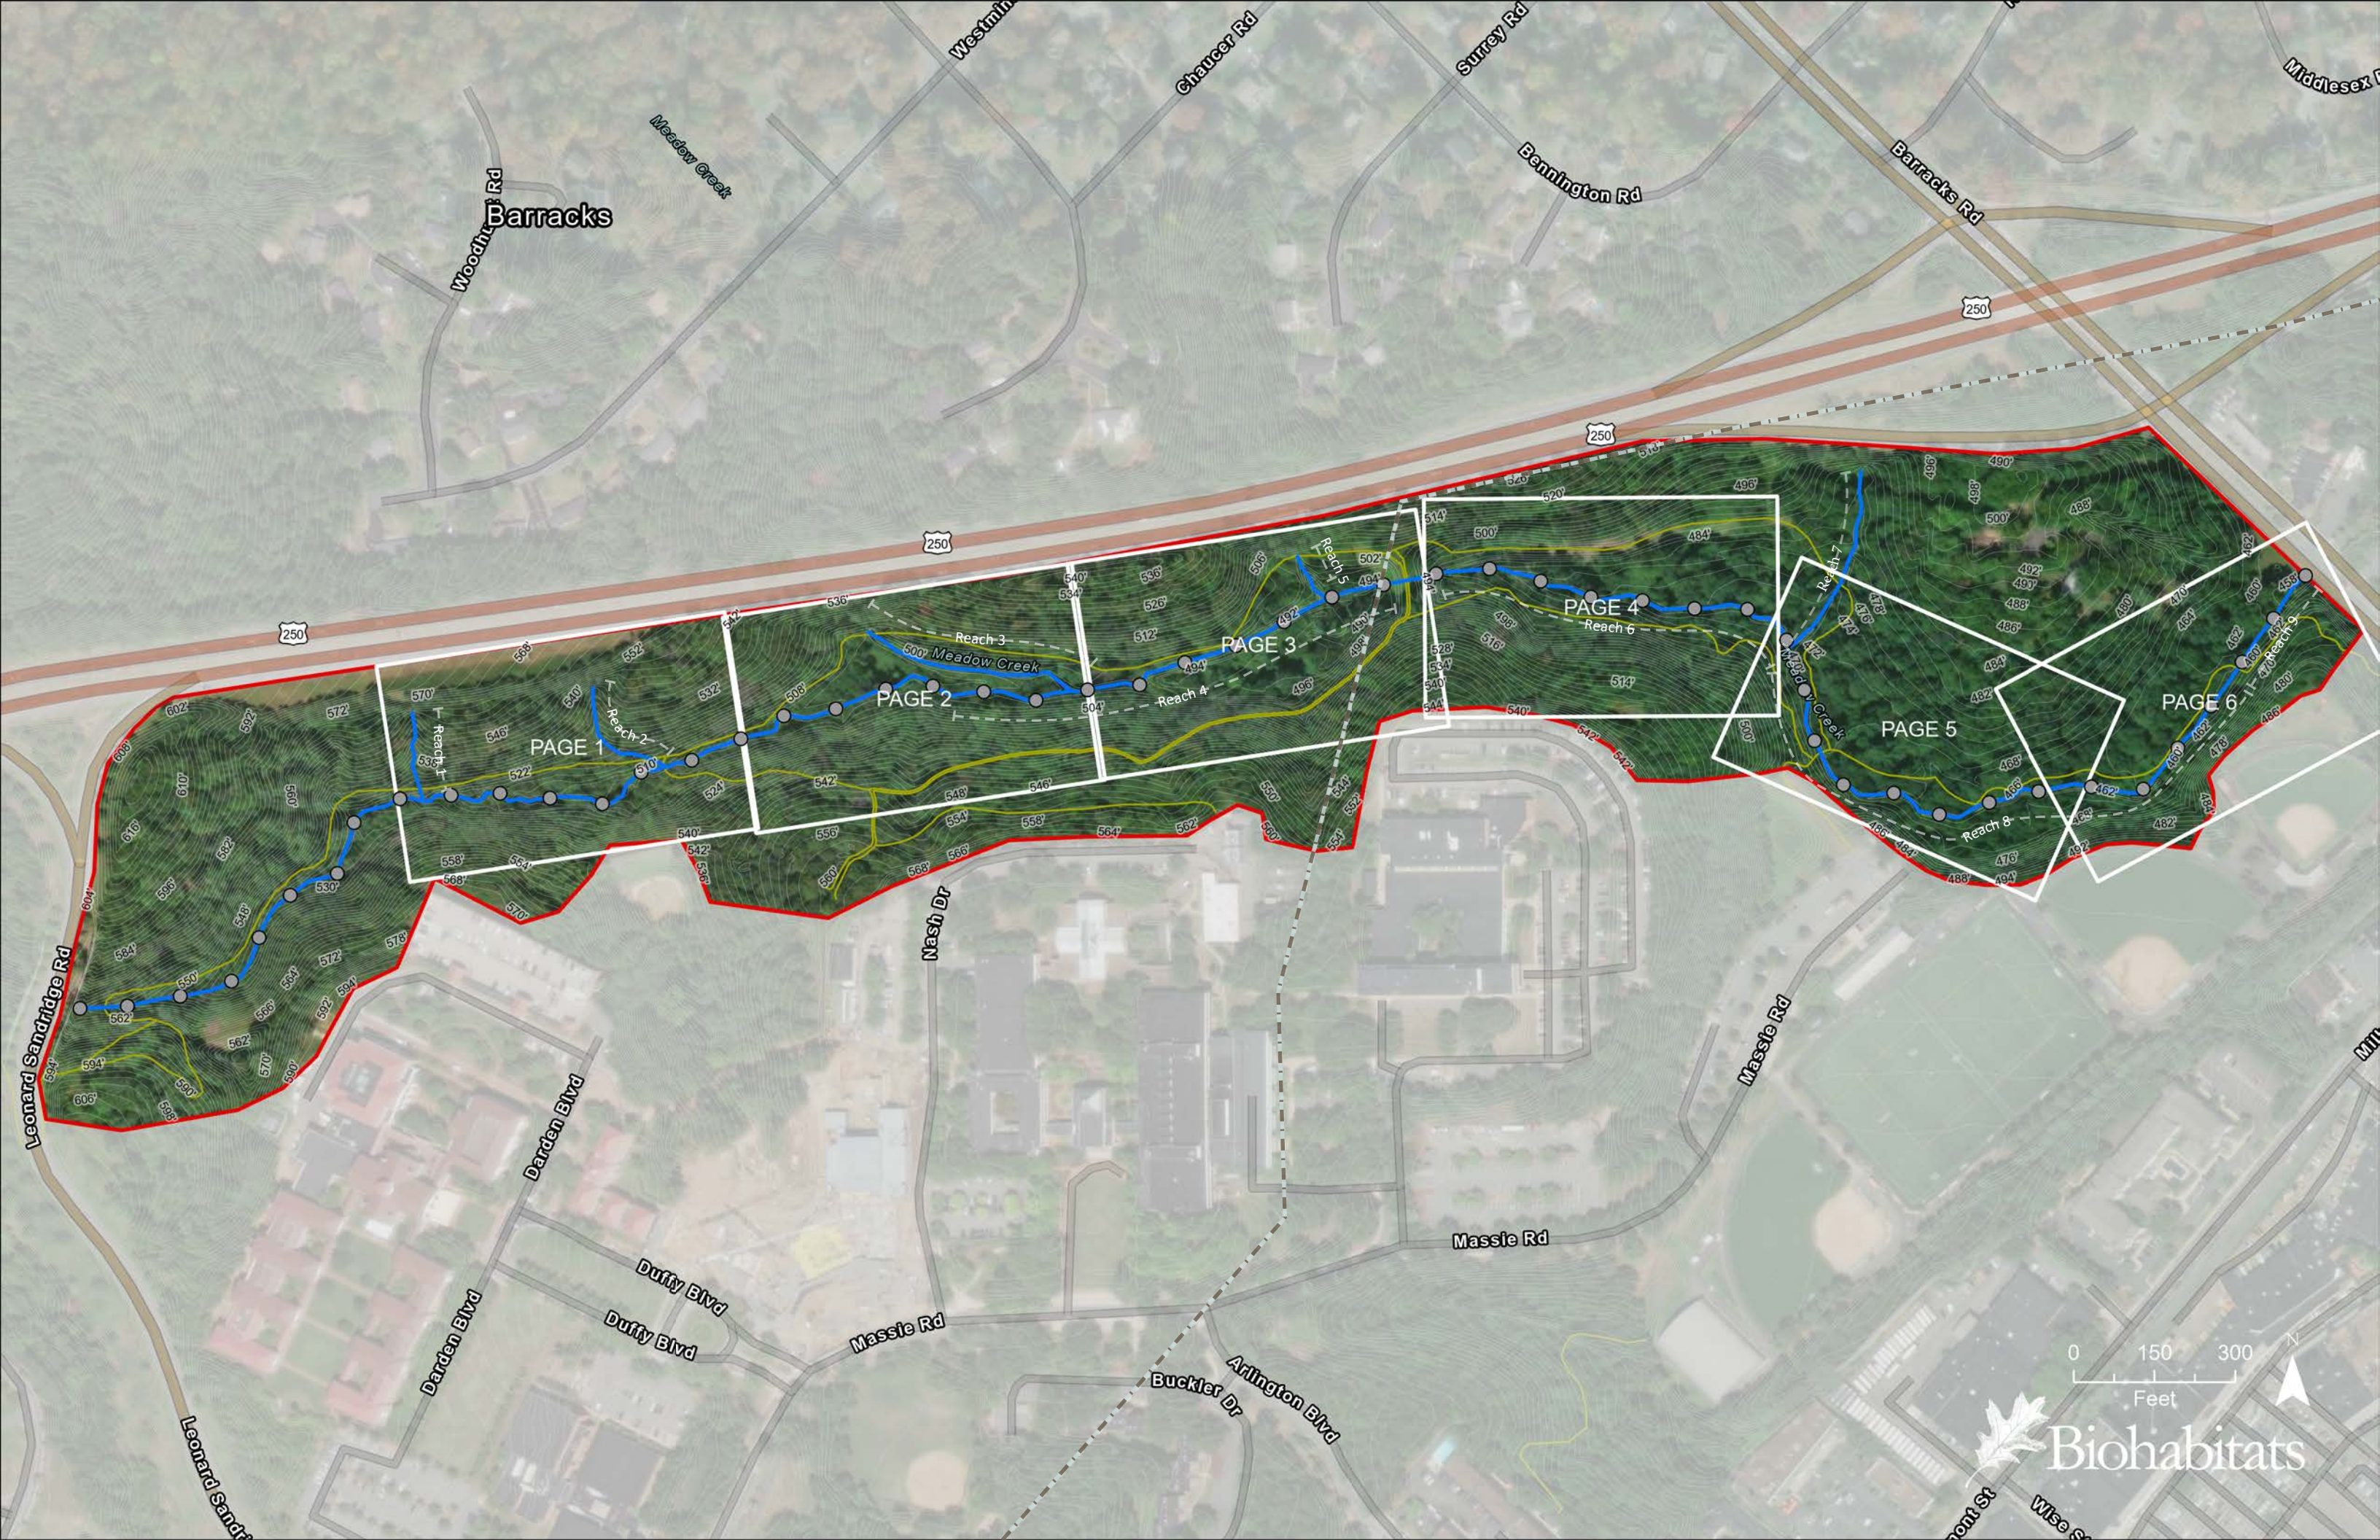
**ATTACHMENT A
OVERALL PROJECT REACH MAP**

The unnamed tributary to Meadow Creek flows from west to east through the site and is approximately 5,000 feet long. The different reach conditions starting at Barracks Road (station 0+00) and ending at Leonard Sandridge Road (station 50+00) are characterized below (see Attachment A for overall reach length and stationing). Proposed restoration reaches that were considered during this assessment are labeled with Reach numbers behind their station designation.

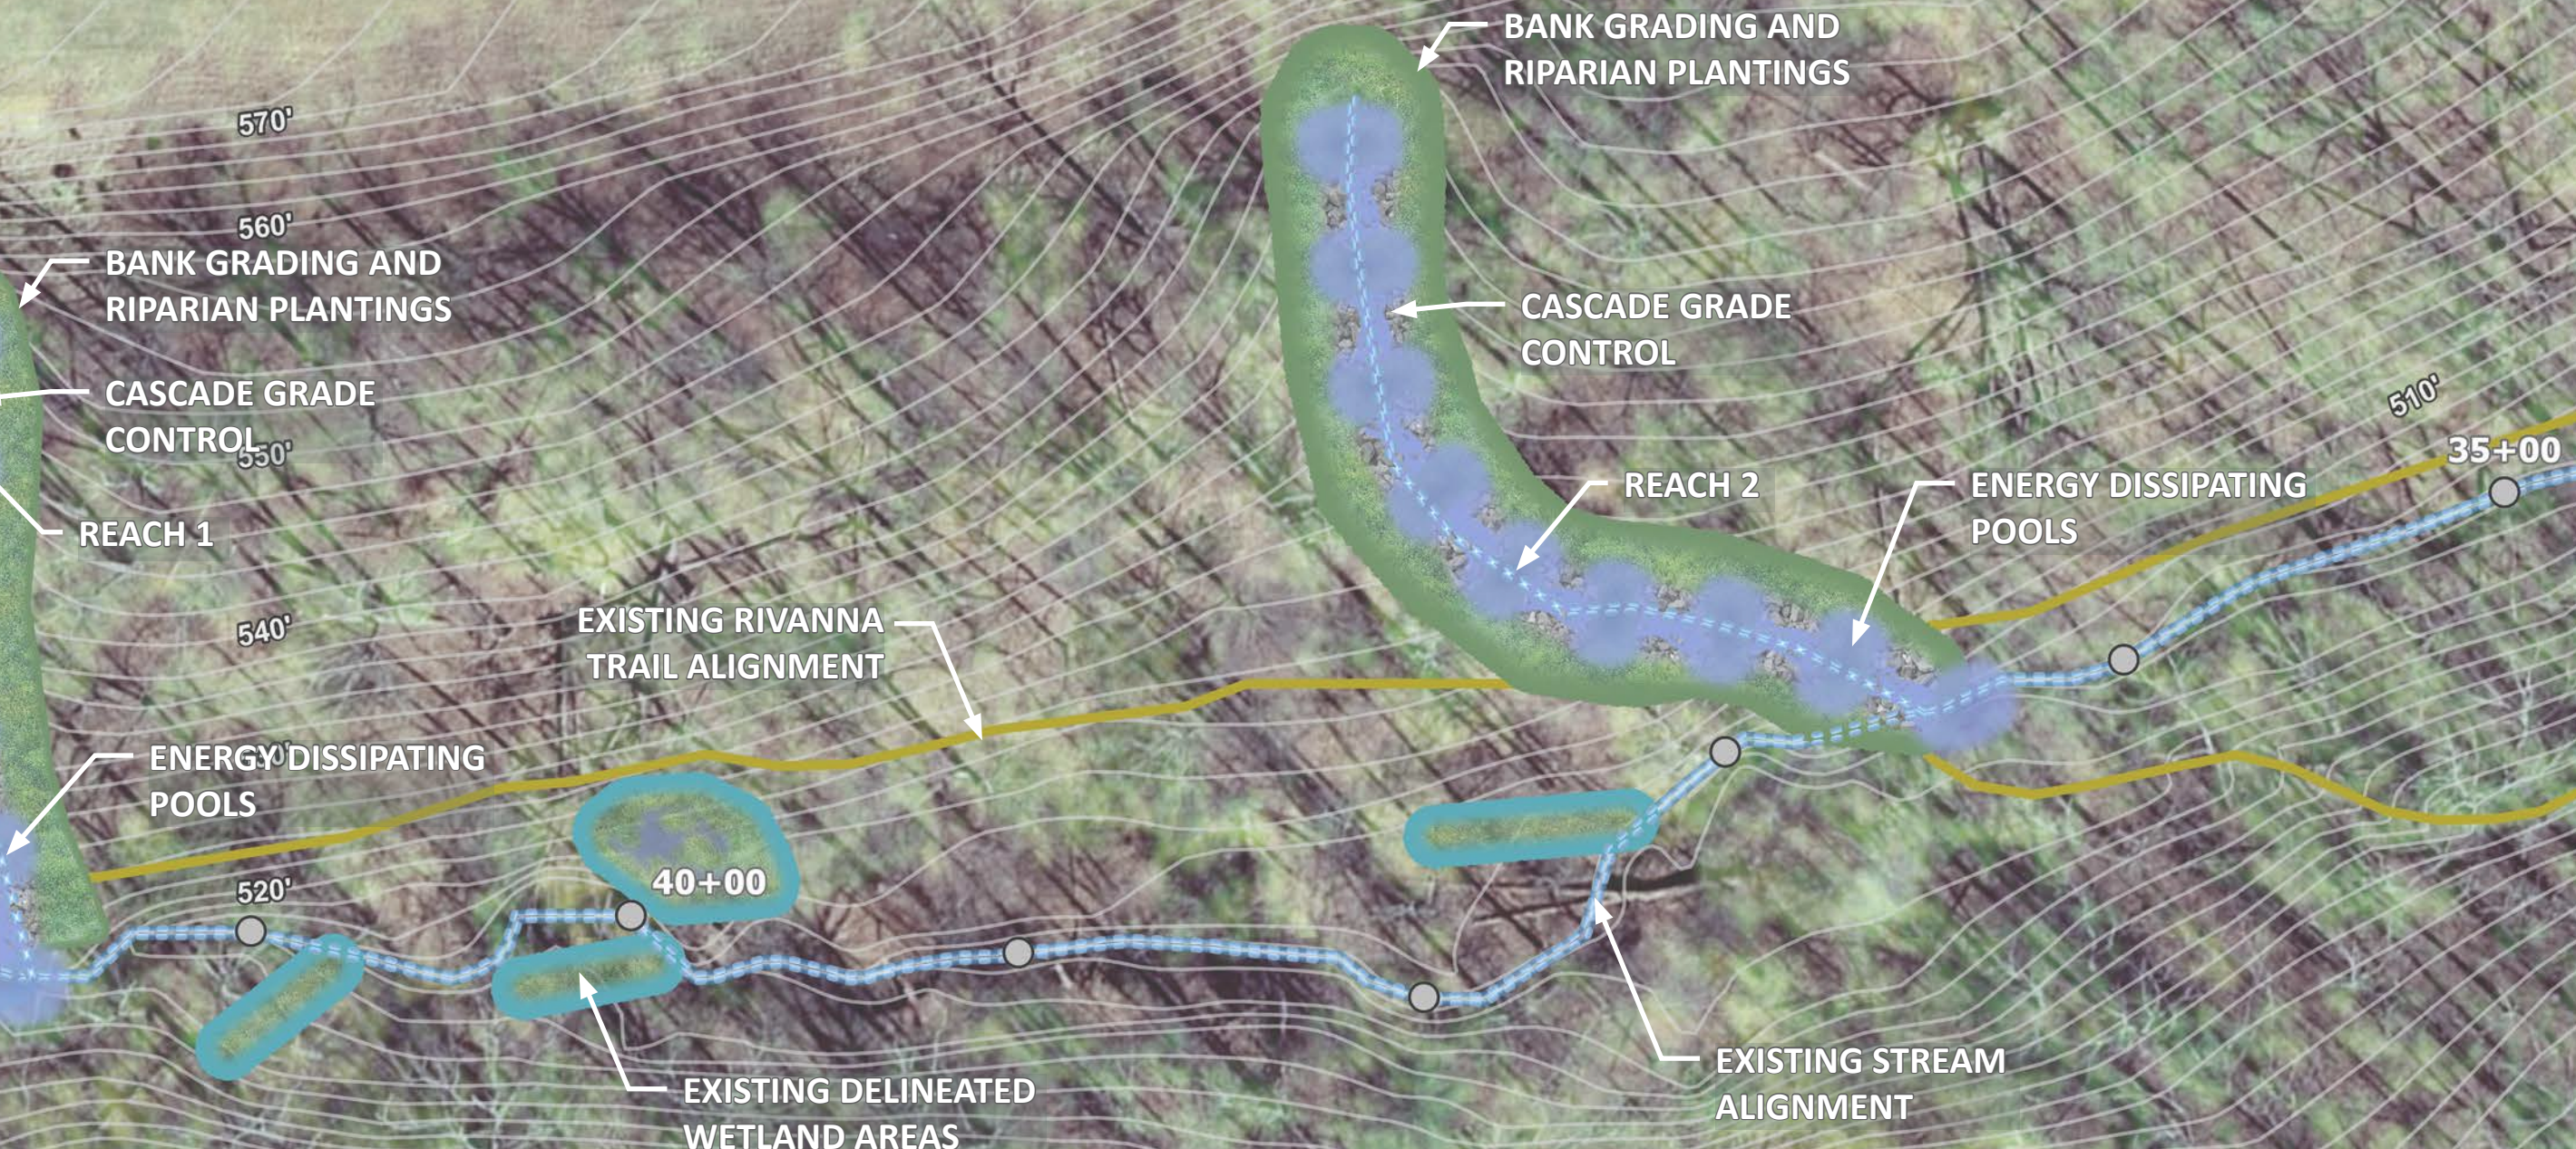
SHEET 1 (BOTH OPTIONS)

UVA TRIBUTARY TO MEADOW CREEK STREAM RESTORATION CONCEPT

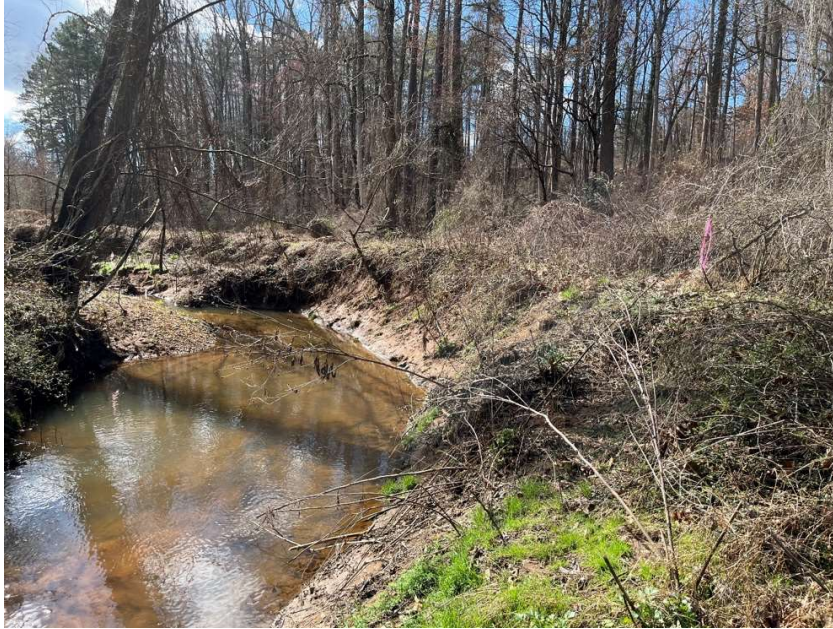
During the 2024 field work it was evident that significant degradation of stream conditions had occurred since the 2019 assessment (See Figure 2). Field measurements were taken at several locations and eroded bank heights had increased by 1-ft on average and the BEHI rating increased to "High" and NBS rating increased to "Moderate". Collected sediment samples had an average bulk density of 74.2 lb/ft³, an average nitrogen concentration of 0.1%, and an average phosphorus concentration of 0.059%. Based on the new assessment and Protocol 1 calculation methods, it was estimated that stream restoration of this reach would result in 12,000 lbs/yr TSS, 23 lbs/yr TP, and 28 lbs/yr TN load reduction (Ches Bay TMDL).

Figure 2 – Typical channel conditions in the Morey Creek study reach
