Rivanna River Combined Benthic and Bacteria Total Maximum Daily Load (TMDL) Action Plan Update

Permit Cycle: 2023-2028

General Permit No.: VAR040073

May 2025

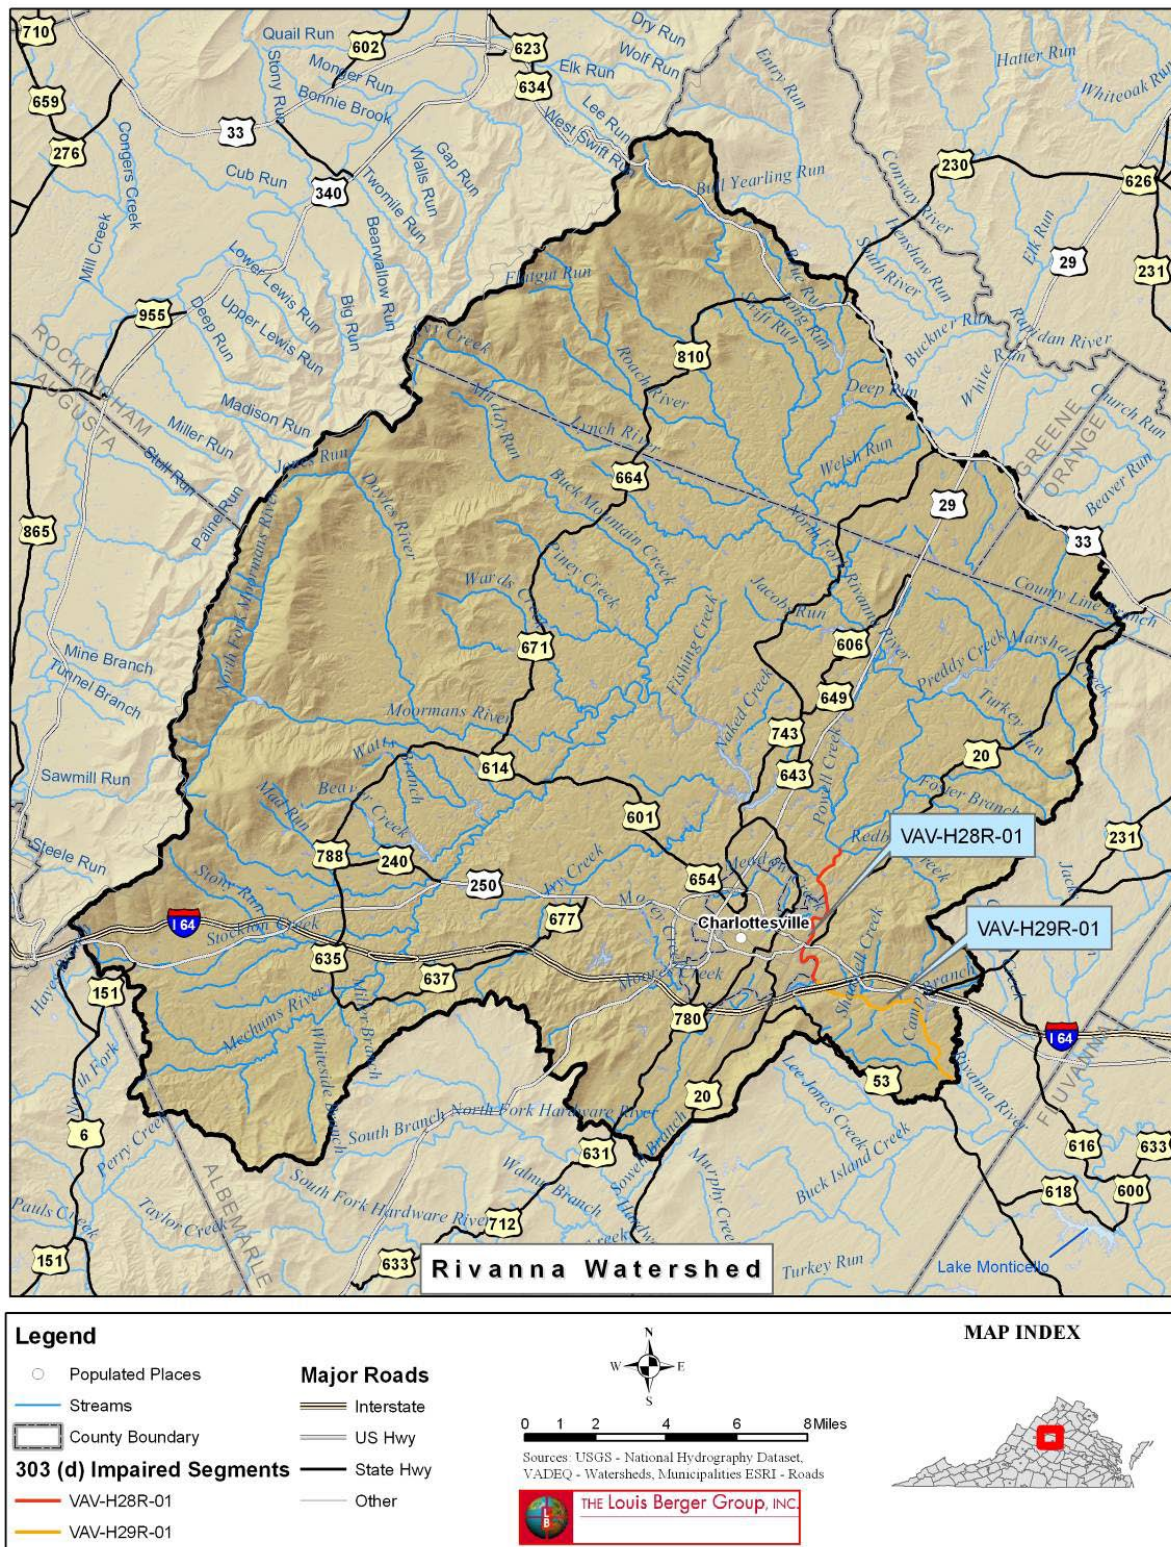
Rivanna River Benthic Impaired Segments and Delineated Watershed

Source: Figure 1-1: Benthic TMDL Development for the Rivanna River Watershed, Final Report (dated March 2008)

The Benthic TMDL report noted in Section 1 identified two separate stream segments with benthic impairments for the mainstem Rivanna River: Segment VAV-H28R-01 and Segment VAV-H29R-01 (Appendix A). These segments, which receive runoff from UVA, are included in Virginia's 303(d) Lists of Impaired Waters as well as the Water Quality Assessment 305(b)/303(d). According to the report, as of 2004 the source of the benthic macroinvertebrate impairment for the upstream segment (VAV-H28R-01) was attributed to non-point source urban runoff. The source of the benthic macroinvertebrate impairment for segment VAV-H29R-01 was unknown at the time the TMDL was completed. However, analysis of the candidate stressors indicate that sedimentation and urban runoff are the most probable cause of the impairment and the basis of the TMDL.

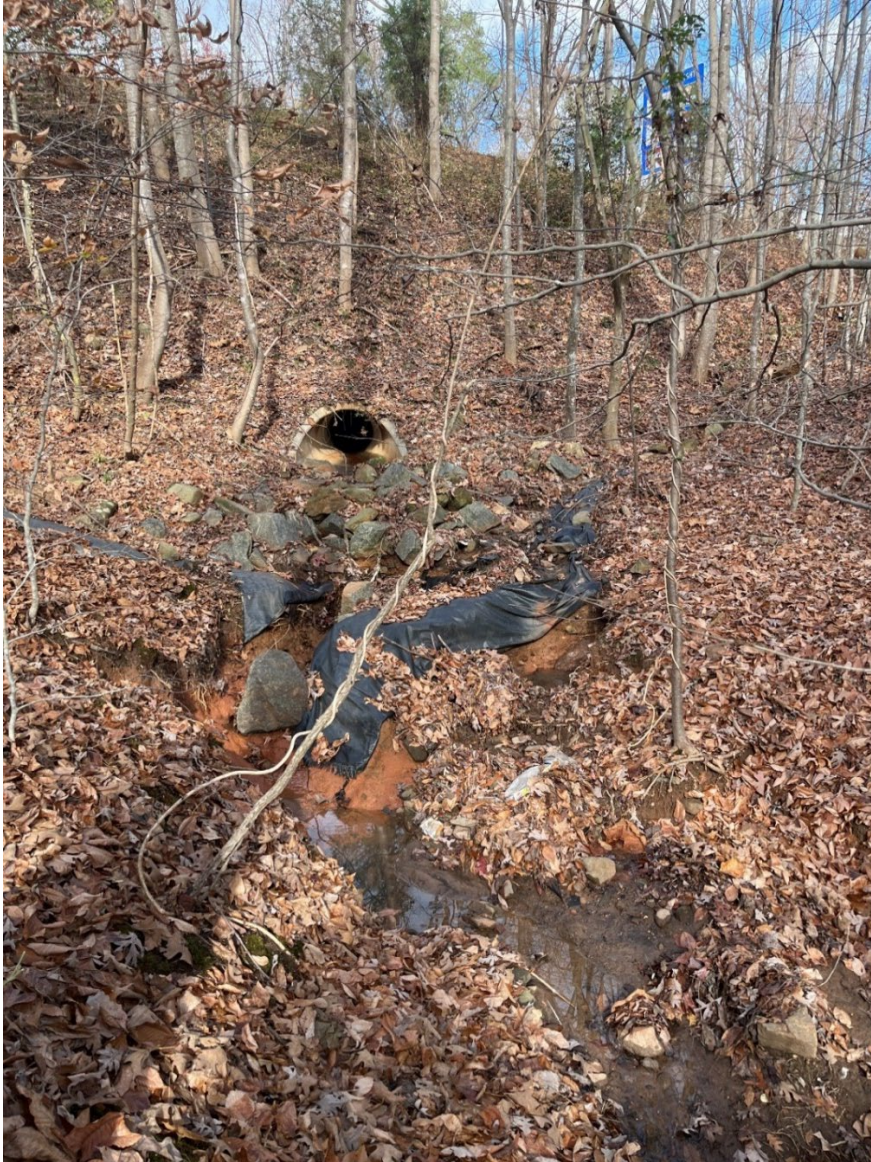
This 125-foot long reach is located in the northwest quadrant of the site. The channel receives flows from a 36-inch diameter pipe which conveys flows from the Route 250/29 bypass. There is a significant headcut approximately 50 feet downstream of the pipe outlet (at the end of the rock apron protection, Photo 1) and another headcut approximately 150 feet downstream of the pipe outlet.

Photo 1: Headcut at Reach 1 outfall.

- Reach 1 – This outfall channel could be stabilized with boulder cascade grade controls in the existing channel to prevent further headcutting erosion (see example Photo 10 below). This would likely require the installation of 2-4 boulder cascades in or around the existing headcut locations. These grade controls would prevent significant vertical downcutting and associated channel erosion. It is anticipated that the Chesapeake Bay Program Protocol 5 – Crediting Outfall and Gully Stabilization Projects would apply to work on this tributary. This reach is the furthest from the anticipated access location from Barracks Road and would be accessed via the Rivanna Trail segment, which may influence the cost-benefit analysis of including this outfall in the proposed work. Access would be relatively simple if VDOT allowed access from the Route 29/250 Bypass.

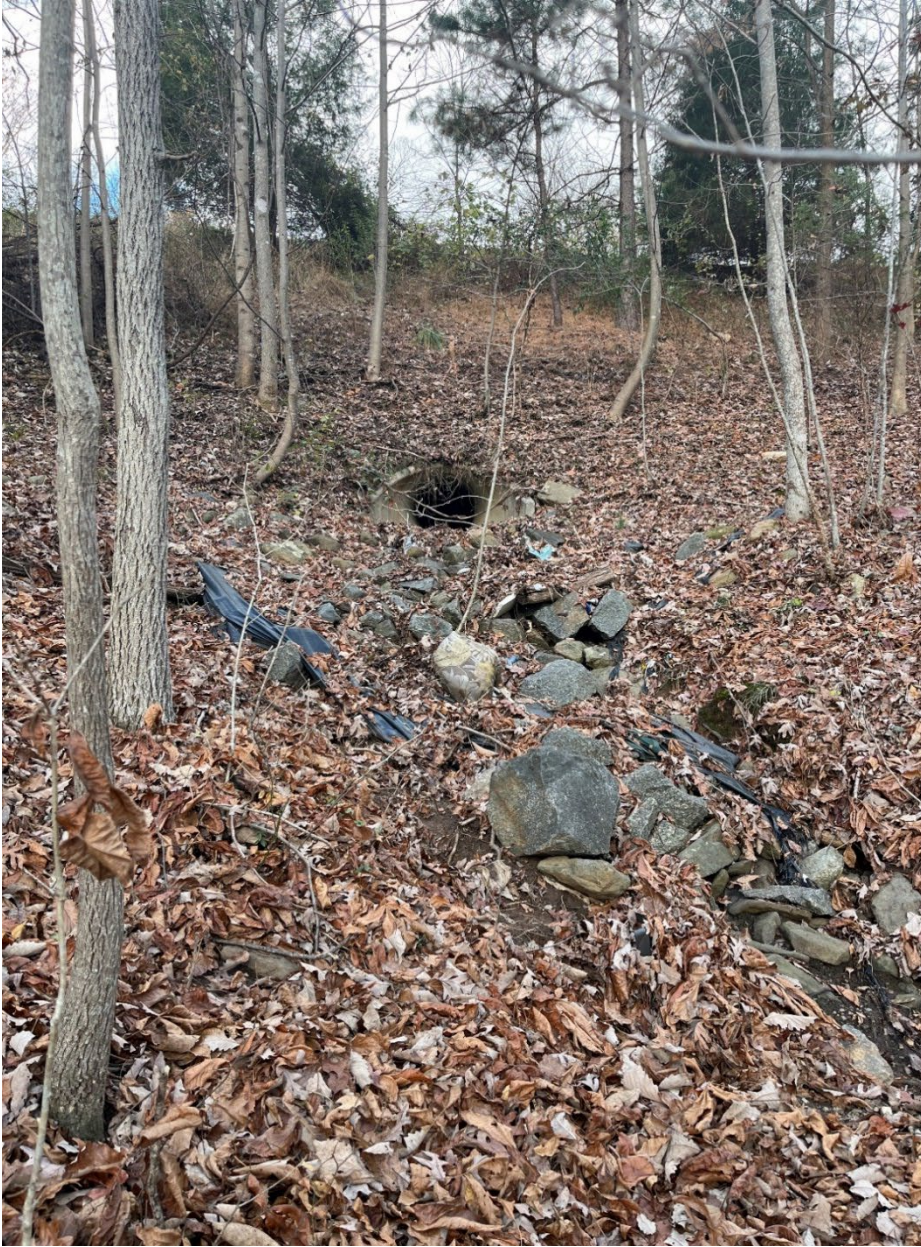
- Reach 2
This 200-foot reach is found approximately 500-feet east of Reach 1. This small intermittent stream channel receives flows from a 24-inch diameter pipe which conveys flows from the Route 250/29 bypass. There is a significant headcut approximately 10 feet downstream of the pipe outlet in the rock apron outlet protection (Photo 2) and another headcut approximately 50 feet downstream of the pipe outlet.

Photo 2: Headcut at Reach 2 outfall.

- Reach 2 - This outfall channel could be stabilized with boulder cascade grade controls in the existing channel to prevent further erosion due to headcutting (see example Photo 11 below). This would likely require the installation of 2-4 boulder cascades in or around the existing headcut locations. These grade controls would prevent significant vertical downcutting and associated channel erosion. It is anticipated that the Chesapeake Bay Program Protocol 5 – Crediting Outfall and Gully Stabilization Projects would apply to work on this tributary. This reach is the second furthest from the anticipated access location near via the Rivanna Trail segment, which may influence the cost-benefit analysis of including outfall in the proposed work. Access would be relatively simple if VDOT allowed access from the Route 29/250 Bypass.

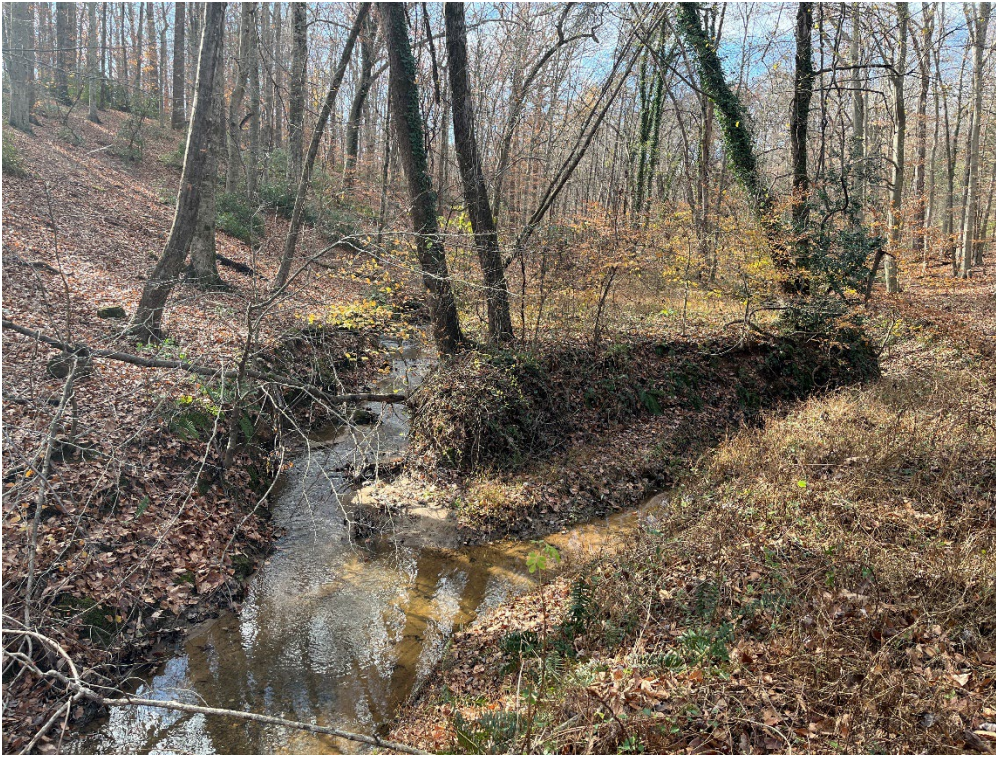
- Reach 3
This 412--foot reach is found approximately 830 feet east of Reach 2. This reach receives stream flow from a five foot by 12-foot box culvert. The channel parallels the main tributary, creating a peninsula between the two channels (Photo 3). The reach is deeply incised with near vertical banks.

Photo 3: Confluence of Reaches 3 and 4 – showing severely entrenched channels within legacy sediments and eroded banks on each reach.

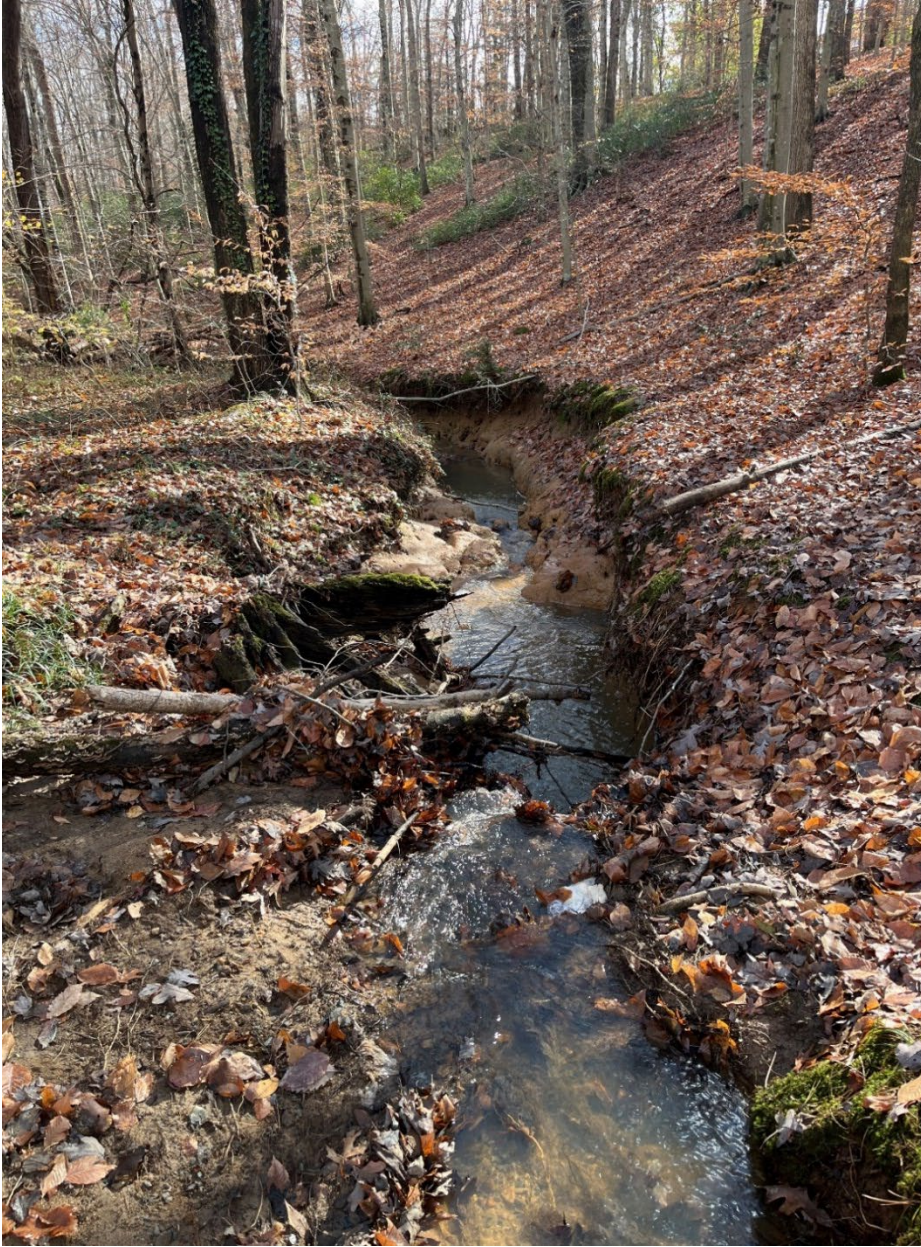
- Reach 4
This 800--foot reach is on the main tributary which traverses the site. It is characterized by an incised channel with near vertical, eroding banks (Photo 4).

Photo 4: Headcut at the upstream end of Reach 4 where channel conditions begin to significantly degrade

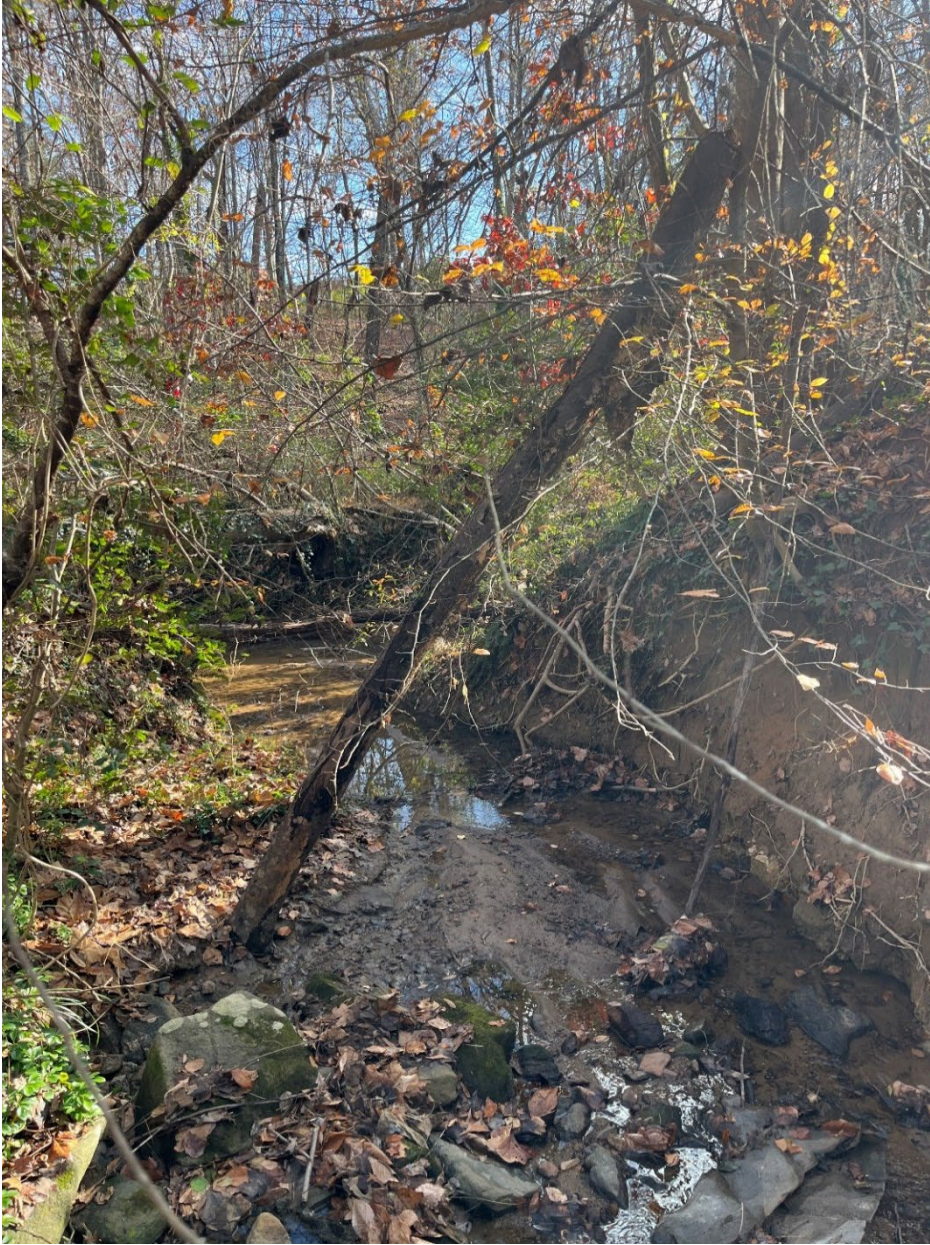
- Reach 5 -
This 100-foot tributary stream channel receives flows from a 40-inch diameter pipe which conveys flows from the Route 250/29 bypass. This steep reach is deeply incised and widened with near vertical eroding banks (Photo 5).

Photo 5: Vertical and highly erodible banks present throughout Reach 5

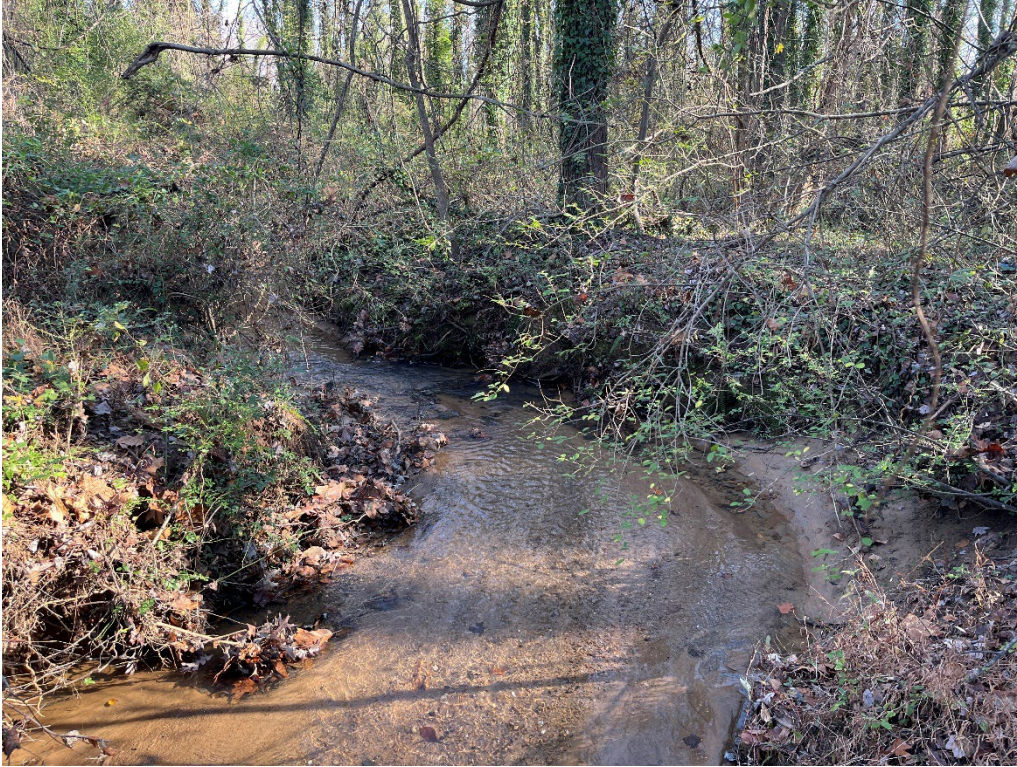
Reach 6 - This 900-foot reach is on the main tributary which traverses the site. It is generally bound by the dam embankment at the upstream end and a Rivanna Trail walking bridge at the downstream end of the reach. It is characterized by a moderately incised channel with near vertical, eroding banks. Riparian vegetation is in poor condition with widespread invasive species throughout the adjacent riparian area (Photo 6).

Photo 6: Moderately eroded banks and invasive vegetation present throughout Reach 6.

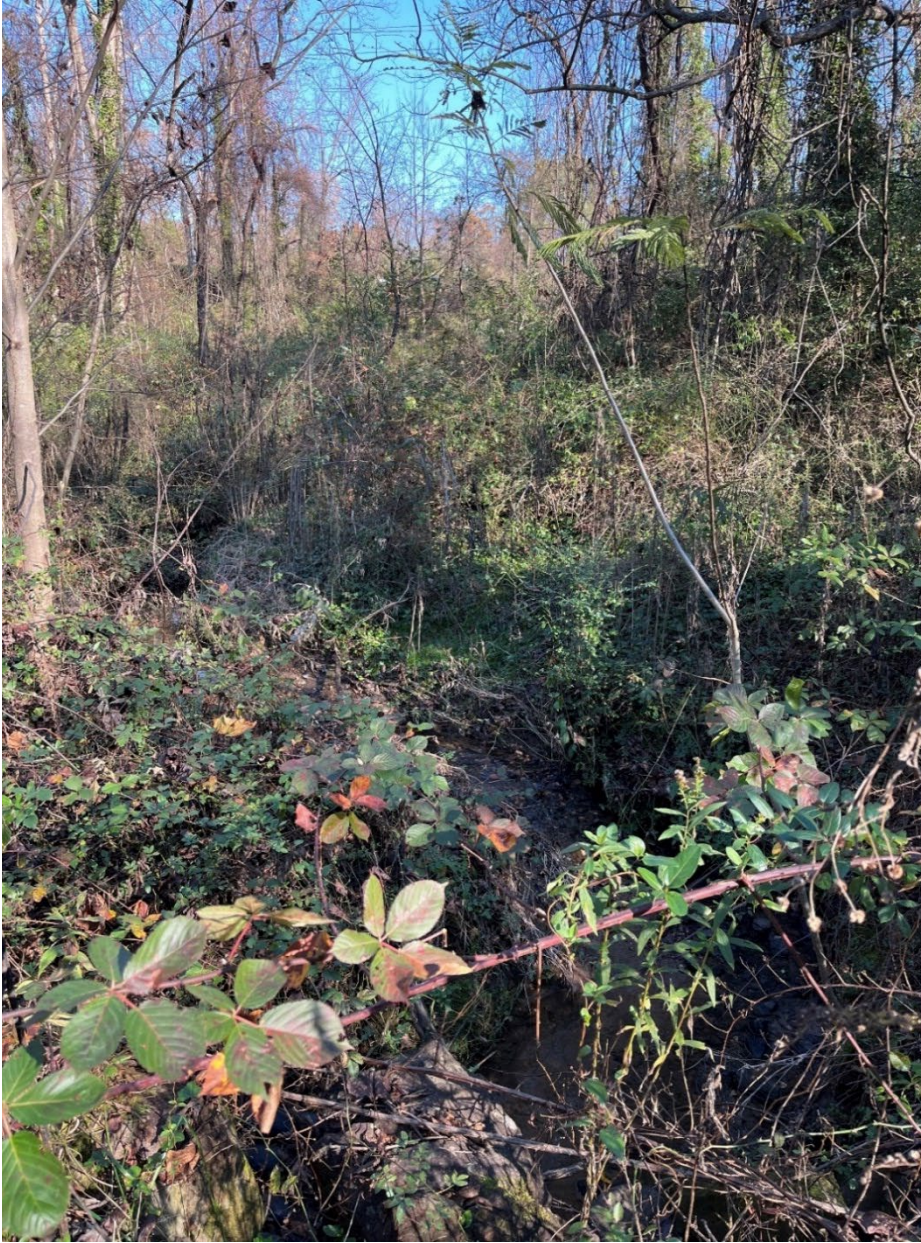
- Reach 7 - This 350-foot reach receives flows from a 30-inch diameter pipe which conveys flows from the Route 250/29 bypass. The reach is in relatively stable condition with vegetated banks, stable plan geometry and vertical profile (Photo 7).

Photo 7: Relatively stable channel conditions present in Reach 7 compared to other outfall tributaries.

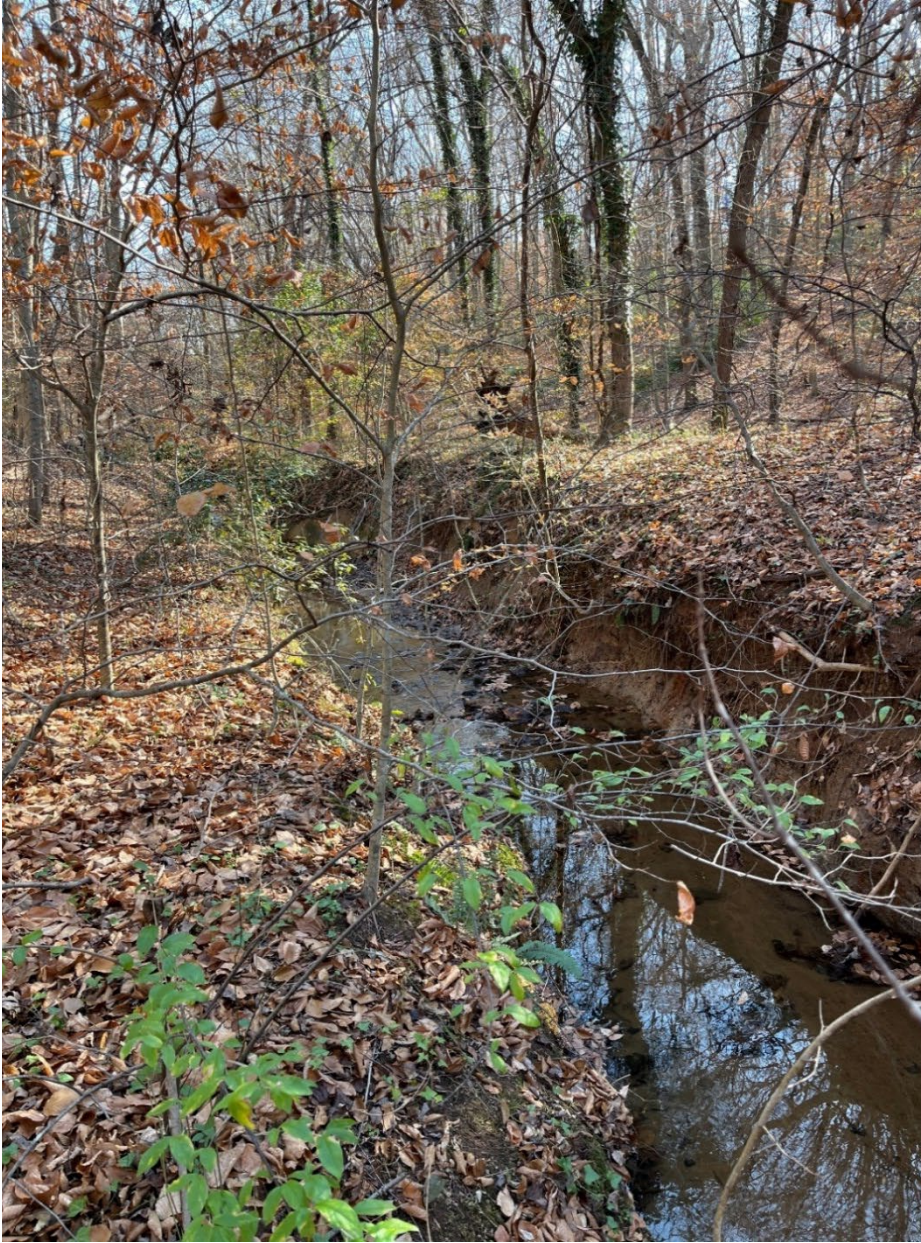
- Reach 8
This 1,000-foot reach is on the main tributary which traverses the site. It is generally bound by two Rivanna Trail walking bridges which cross the stream. It is characterized by an incised channel with near vertical, eroding banks (Photo 8). This reach may also be impacted by legacy sediments from the breached stone dam found about 100 feet downstream from the Trail walking bridge nearest Barracks Road. Riparian vegetation is in poor condition with widespread invasive species throughout the adjacent riparian area.

Photo 8: Vertical and highly erodible banks present throughout Reach 8

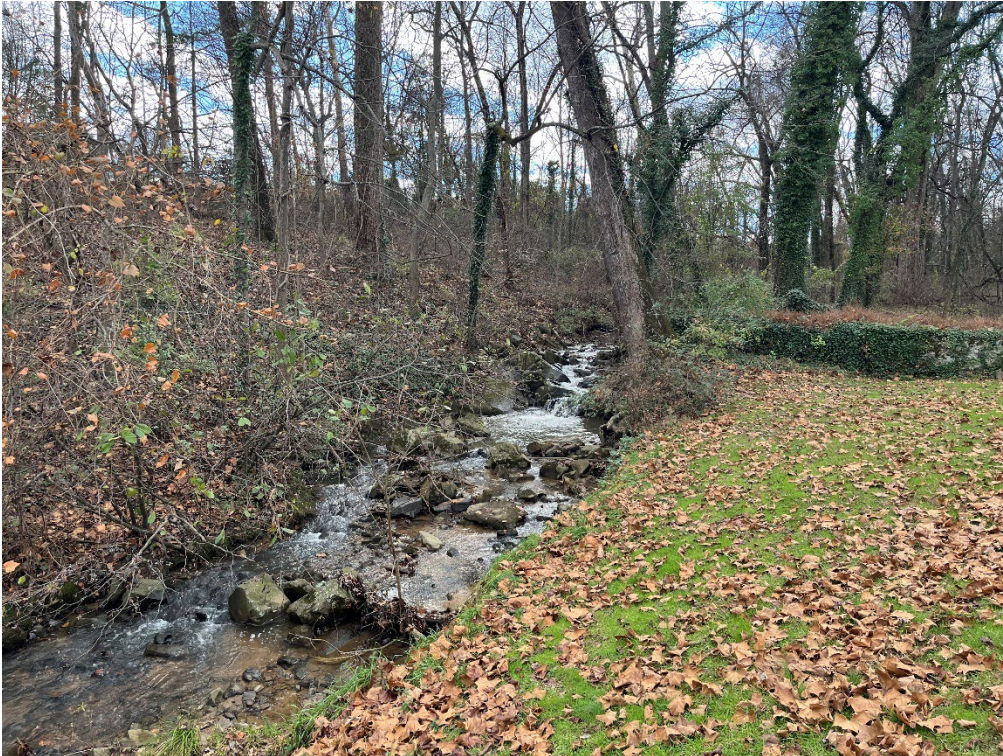
- Reach 9
This 200-foot reach is in stable condition with vegetated banks and bedrock grade control (Photo 9). The reach is between the easternmost Rivanna Trails walking bridge and the culvert under Barracks Road

Photo 9: Relatively stable channel conditions present in Reach 9 compared to other main tributary reaches.

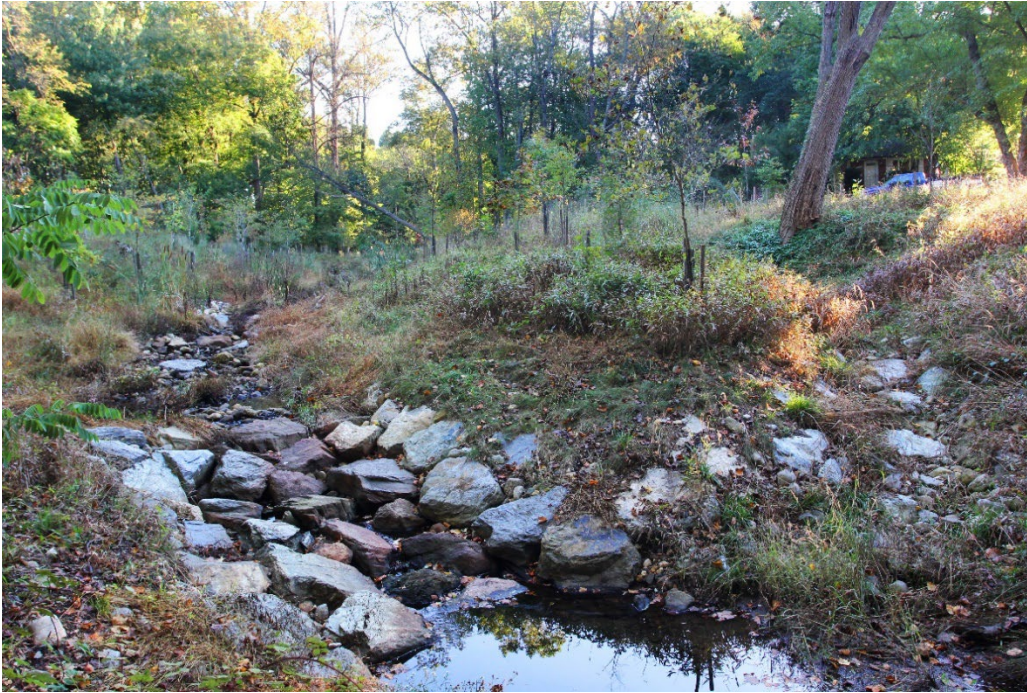
Photo 10: Example of boulder cascade channel stabilization.

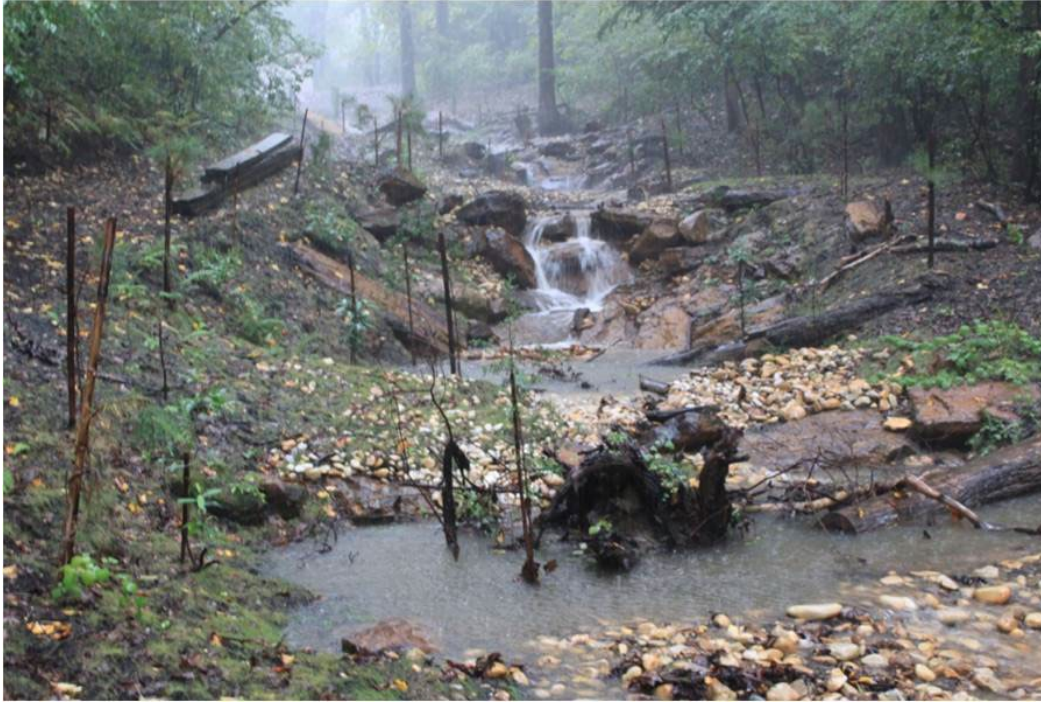
Photo 11: Example of boulder cascade channel stabilization.

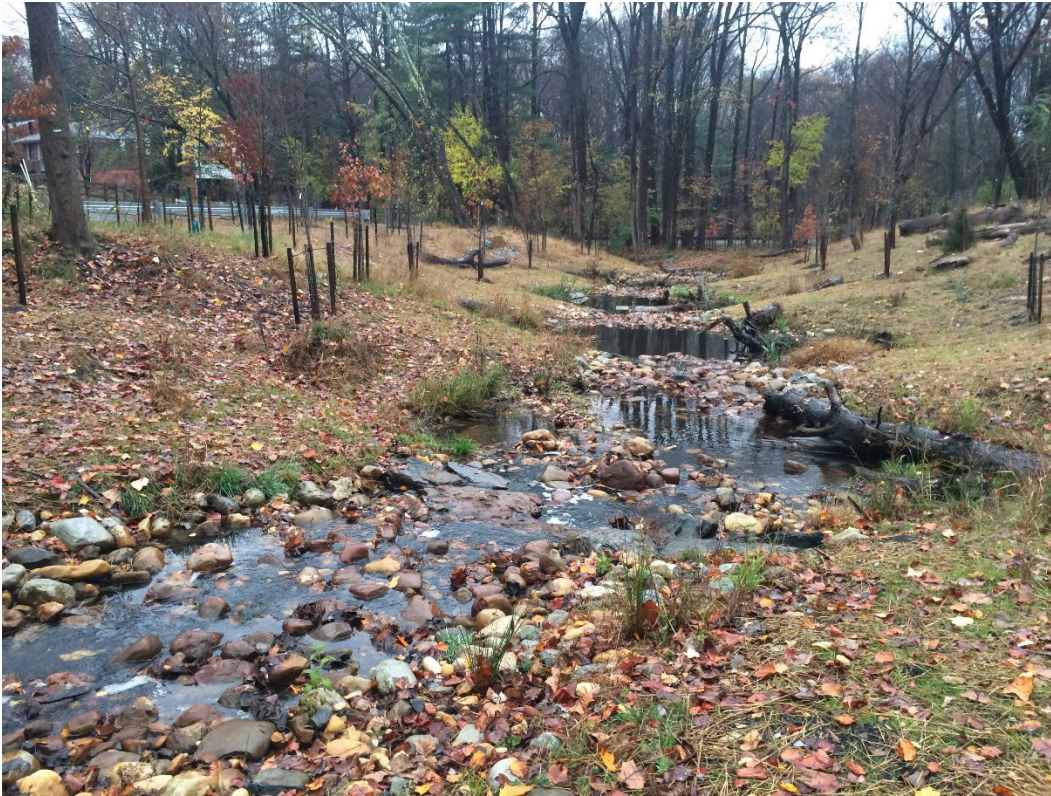
Photo 12: Example of riffle pool restoration with raise in channel bed and bank grading.

- Reach 3 – This perennial tributary channel could be restored with a series of riffles or cascade structures constructed within the existing channel (see example Photo 12 below). The channel bed could be raised to lessen channel entrenchment and bank slopes could be graded to a stable slope for vegetation establishment. The installation of the grade control structures and increase in bank stability will result in significantly less channel erosion potential. Raising the channel bed will increase hyporheic flow and increase nutrient capture. This was the type of intervention installed at the John Paul Jones Arena stream reach in 2021. This restoration approach will require some short-term impacts to aquatic habitat, but these impacts will be outweighed by the long-term benefits of re-establishing a more stable channel with improved aquatic habitat and reconnection with the adjacent floodplain. It is anticipated that the Chesapeake Bay Program Protocol 1 –Credit for Prevented Sediment during Storm Flow and Protocol 2 – Credit for Instream and Riparian Nutrient Processing during Baseflow would apply to work on this tributary. It is assumed that construction access to this reach would need to be accomplished from the adjacent Rivanna Trail segment.

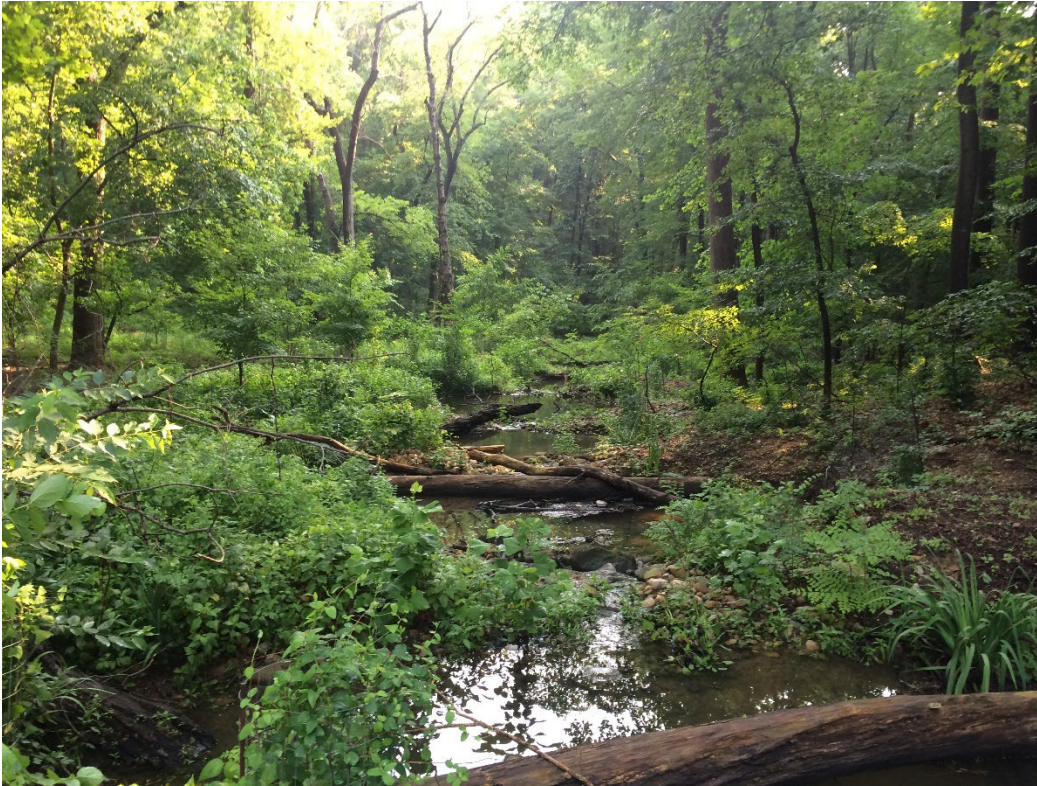
Photo 13: Example of riffle pool restoration with incorporated large woody debris with raise in channel bed and bank grading.

- Reach 4 – This portion of the main channel in the former pond impoundment area could be restored with a series rock and large woody debris grade control structures in the existing channel (see example Photo 13 below). The channel bed could be raised to provide low banks and enhanced connection with the adjacent floodplain. The installation of the grade control structures and increase in bank stability will result in significantly less channel erosion potential. Raising the channel bed will increase hyporheic flow and increase nutrient capture as well as providing a more frequent connection with the adjacent floodplain to reduce erosive forces on the channel and deposit nutrients on the floodplain. This restoration approach will require some short-term impacts to aquatic habitat, but these impacts will be outweighed by the long-term benefits of re-establishing a more stable channel with improved aquatic habitat and reconnection with the adjacent floodplain. It is anticipated that the Chesapeake Bay Program Protocol 1 –Credit for Prevented Sediment during Storm Flow and Protocol 2 – Credit for Instream and Riparian Nutrient Processing during Baseflow would apply to work on this reach of the main channel. Protocol 3 – Credit for Floodplain Reconnection Volume may apply to work on this reach of the main channel, but it is not included in preliminary load reduction computations due required modeling to be completed in detailed design phases. It is assumed that construction access to this reach would need to be accomplished from the adjacent Rivanna Trail segment.

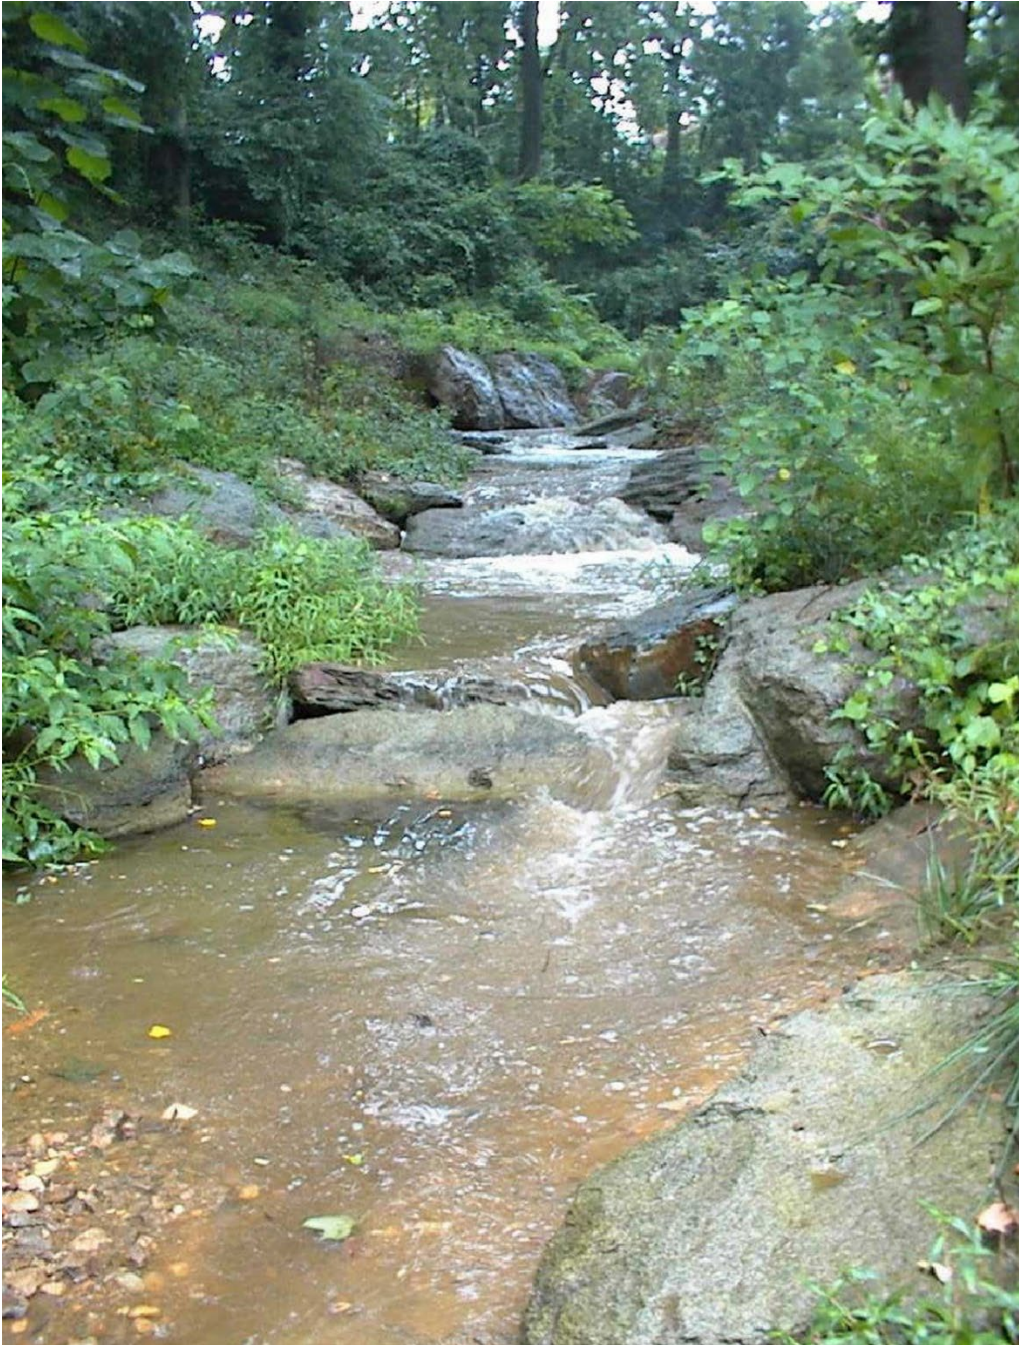
Photo 14: Example of cascade pool restoration with raise in channel bed and bank grading.

- Reach 5 – This perennial tributary channel could be restored with a series cascade structures due to its steepness (see example Photo 14 below). The channel bed could be raised to lessen channel entrenchment and bank slopes could be graded to a stable slope for vegetation establishment. The installation of the grade control structures and increase in bank stability will result in significantly less channel erosion potential. Raising the channel bed will increase hyporheic flow and increase nutrient capture. This restoration approach will require some short-term impacts to aquatic habitat, but these impacts will be outweighed by the long-term benefits of re-establishing a more stable channel with improved aquatic habitat and reconnection with the adjacent floodplain. It is anticipated that the Chesapeake Bay Program Protocol 1 –Credit for Prevented Sediment during Storm Flow and Protocol 2 – Credit for Instream and Riparian Nutrient Processing during Baseflow would apply to work on this tributary. It is assumed that construction access to this reach would need to be accomplished from the adjacent Rivanna Trail segment.

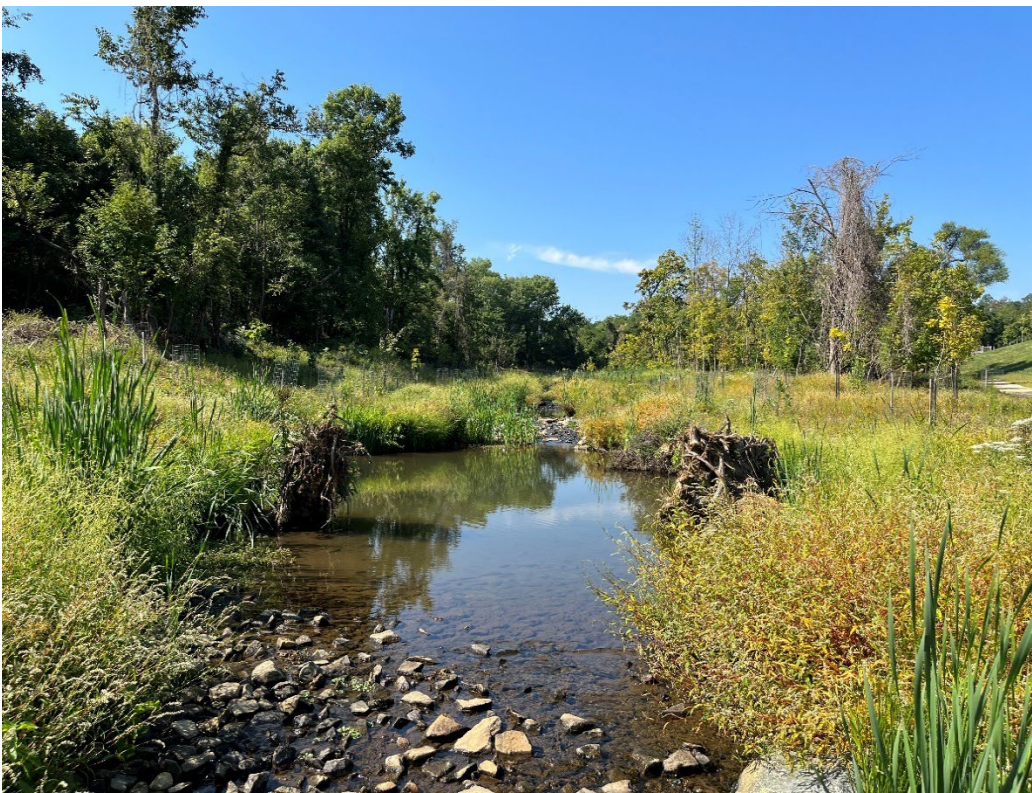
Photo 15: Example of riffle pool restoration with floodplain reconnection and large woody debris installations.

- Reach 6 - This portion of the main channel below the pond embankment to the first Rivanna Trail walking bridge could be restored in a similar manner to Reach 4 with a series rock and large woody debris grade control structures in the existing channel (see example Photo 15 below). The channel bed could be raised to provide low banks and enhanced connection with the adjacent floodplain. This reach also has low quality riparian vegetation with widespread presence of invasive species. The restoration in this area should include invasive treatments and maintained establishment of native riparian vegetation. The installation of the grade control structures and increase in bank stability will result in

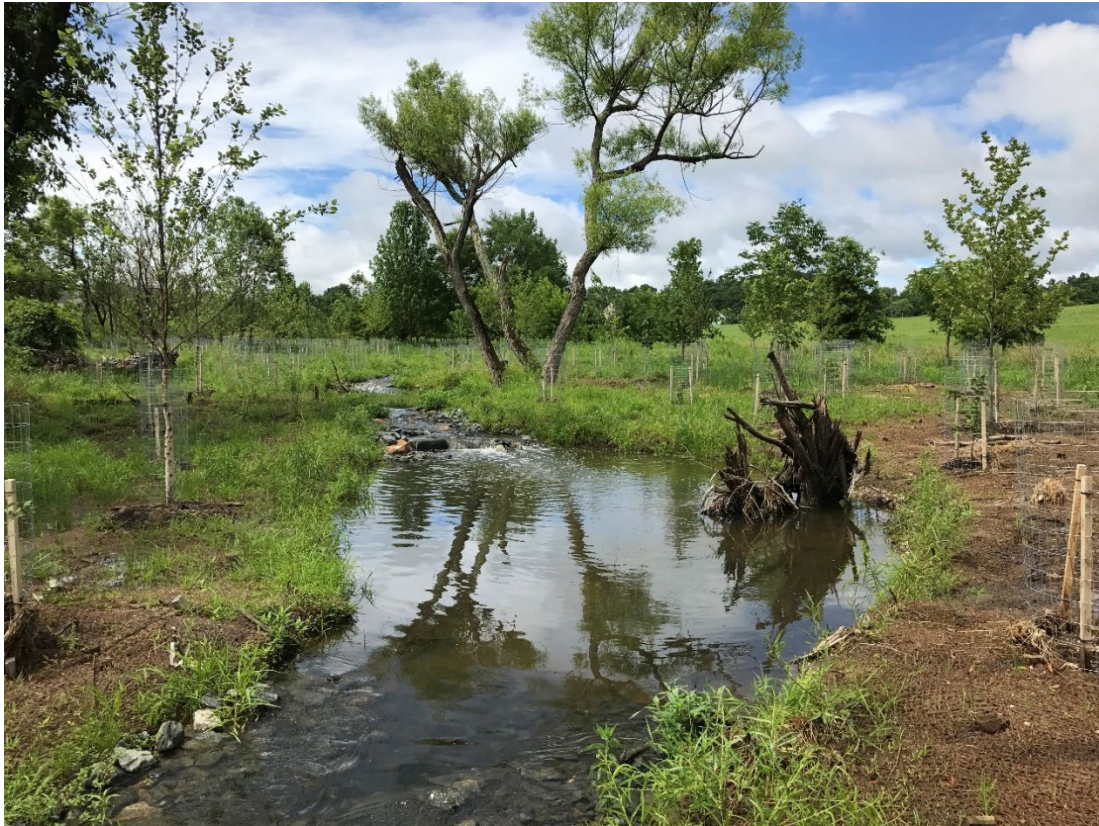
Photo 15: Example of natural channel design channel with enhanced floodplain connection and large woody debris installations.

- Reach 8 – Alt 2 - This portion of the main channel could be restored by creating a new stable channel alignment using Natural Channel Design techniques (see example Photo 16 below). Available floodplain area and poor-quality riparian vegetation in this area make it the best candidate of all the reaches for channel relocation. The relocated channel will be designed for more frequent connection with the adjacent floodplain, stable planform geometry, and stable grade controls at transitions between meander bends. This reach also has low quality riparian vegetation with widespread presence of invasive species. The restoration in this area should include invasive treatments and maintained establishment of native riparian vegetation. The new stable channel design will increase bank stability and will result in significantly less channel erosion potential. Raising the channel bed will increase hyporheic flow and increase nutrient capture as well as providing a more frequent connection with the adjacent floodplain to reduce erosive forces on the channel and deposit nutrients on the floodplain. This restoration approach will require some short-term impacts to aquatic habitat, but these impacts will be outweighed by the long-term benefits of re-establishing a more stable channel with improved aquatic habitat and reconnection with the adjacent floodplain. It is anticipated that the Chesapeake Bay Program Protocol 1 –Credit for Prevented Sediment during Storm Flow and Protocol 2 – Credit for Instream and Riparian Nutrient Processing during Baseflow would apply to work on this reach of the main channel. Protocol 3 – Credit for Floodplain Reconnection Volume may apply to work on this reach of the main channel, but it is not included in preliminary load reduction computations due required modeling to be completed in detailed design phases. It is assumed that construction access to this reach would result in temporary relocation of the Rivanna trail during removal of invasive species and construction activities.
