Rivanna River Combined Benthic and Bacteria Total Maximum Daily Load (TMDL) Action Plan Update

Permit Cycle: 2023-2028

General Permit No.: VAR040073

May 2025

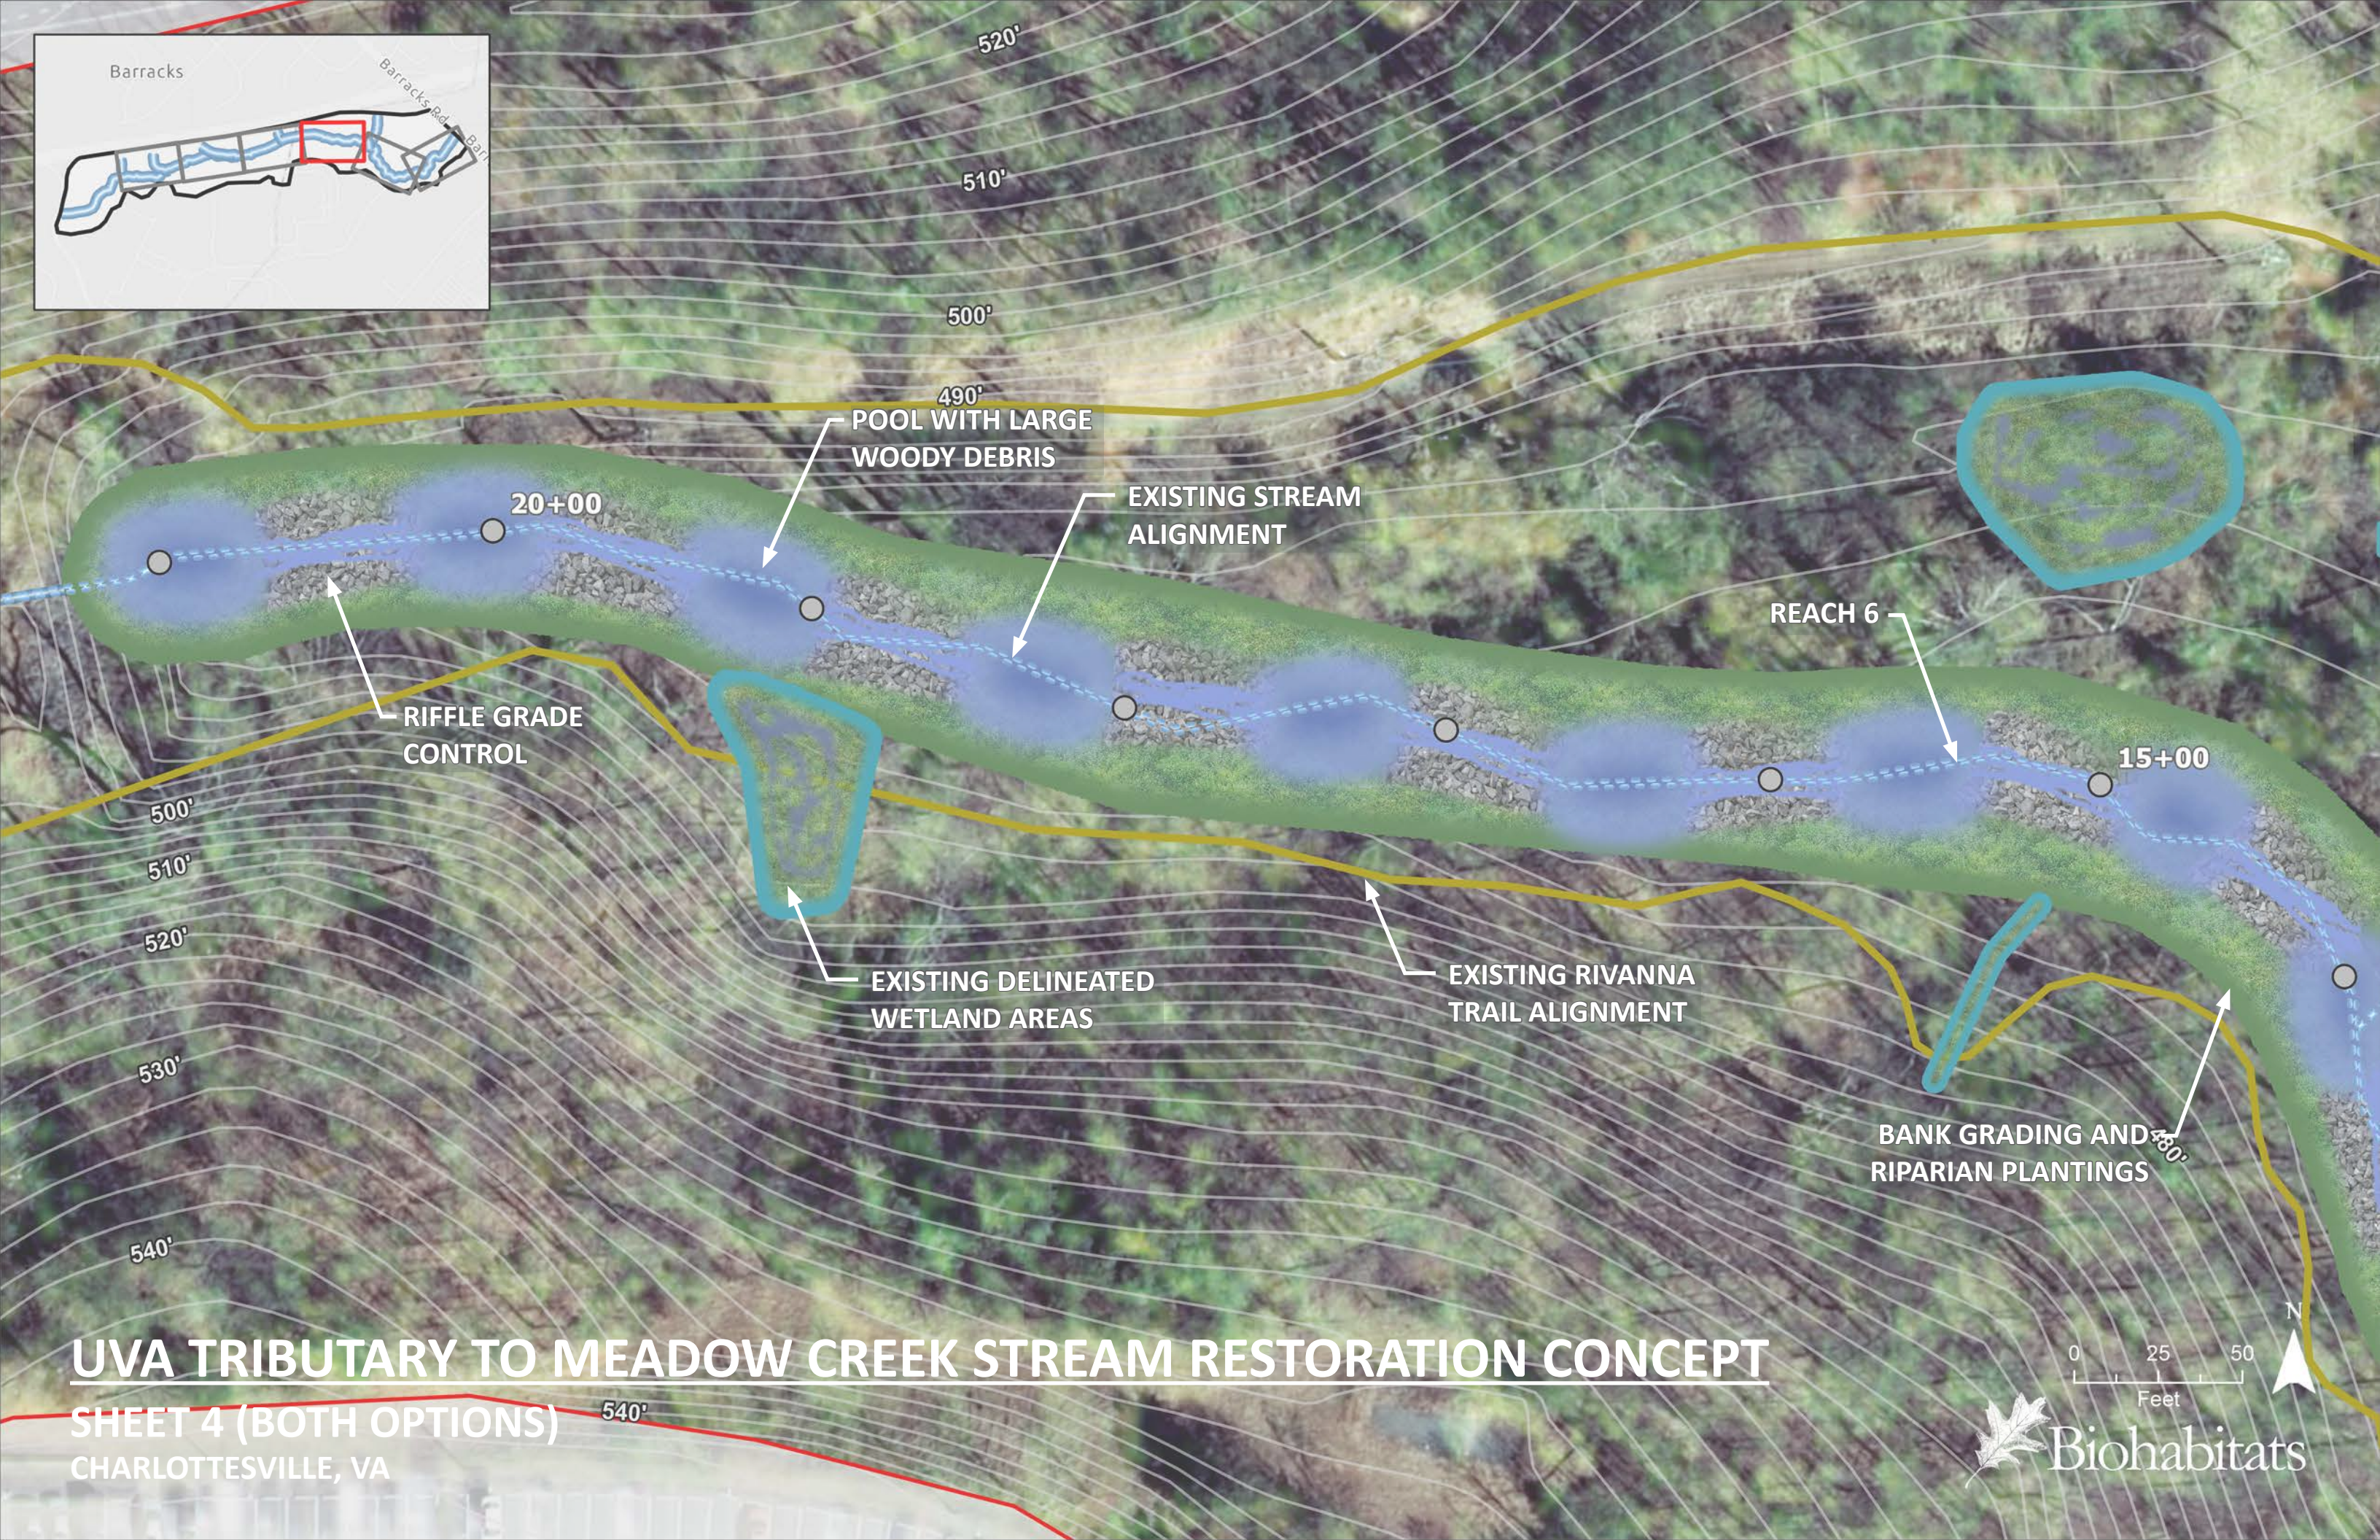
SHEET 4 (BOTH OPTIONS)
CHARLOTTESVILLE, VA

UVA TRIBUTARY TO MEADOW CREEK STREAM RESTORATION CONCEPT

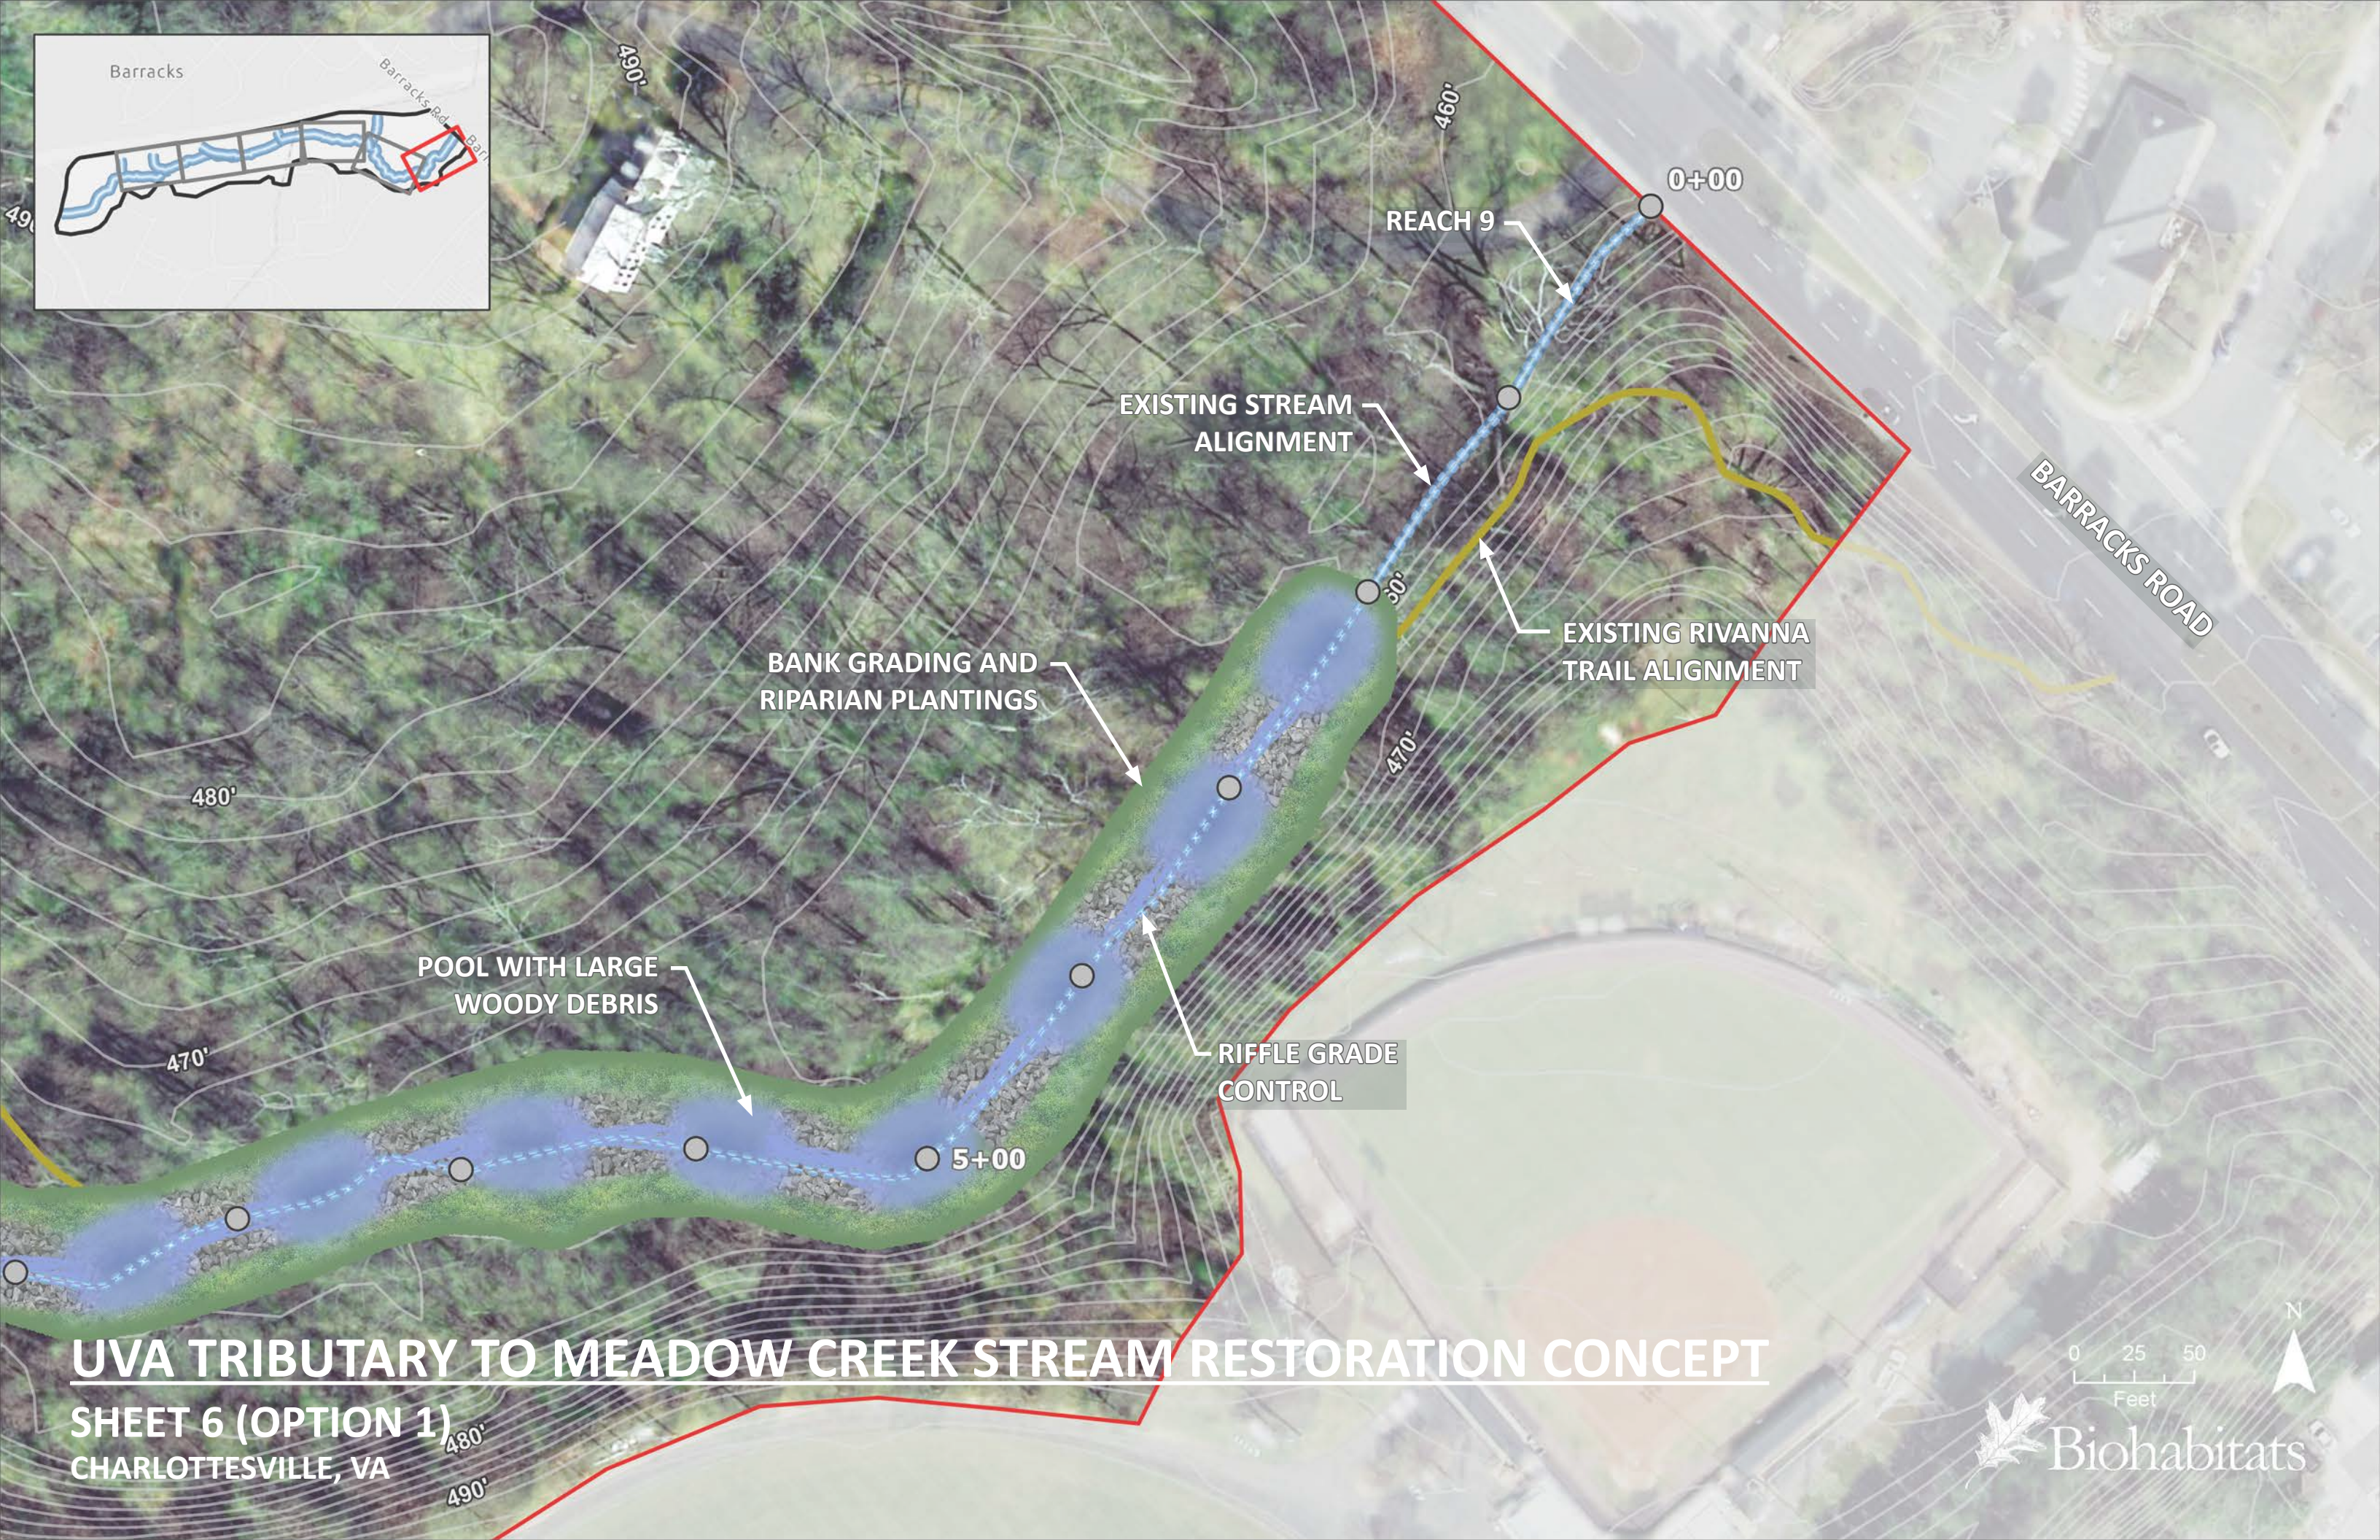
SHEET 6 (OPTION 1)
CHARLOTTESVILLE, VA

UVA TRIBUTARY TO MEADOW CREEK STREAM RESTORATION CONCEPT

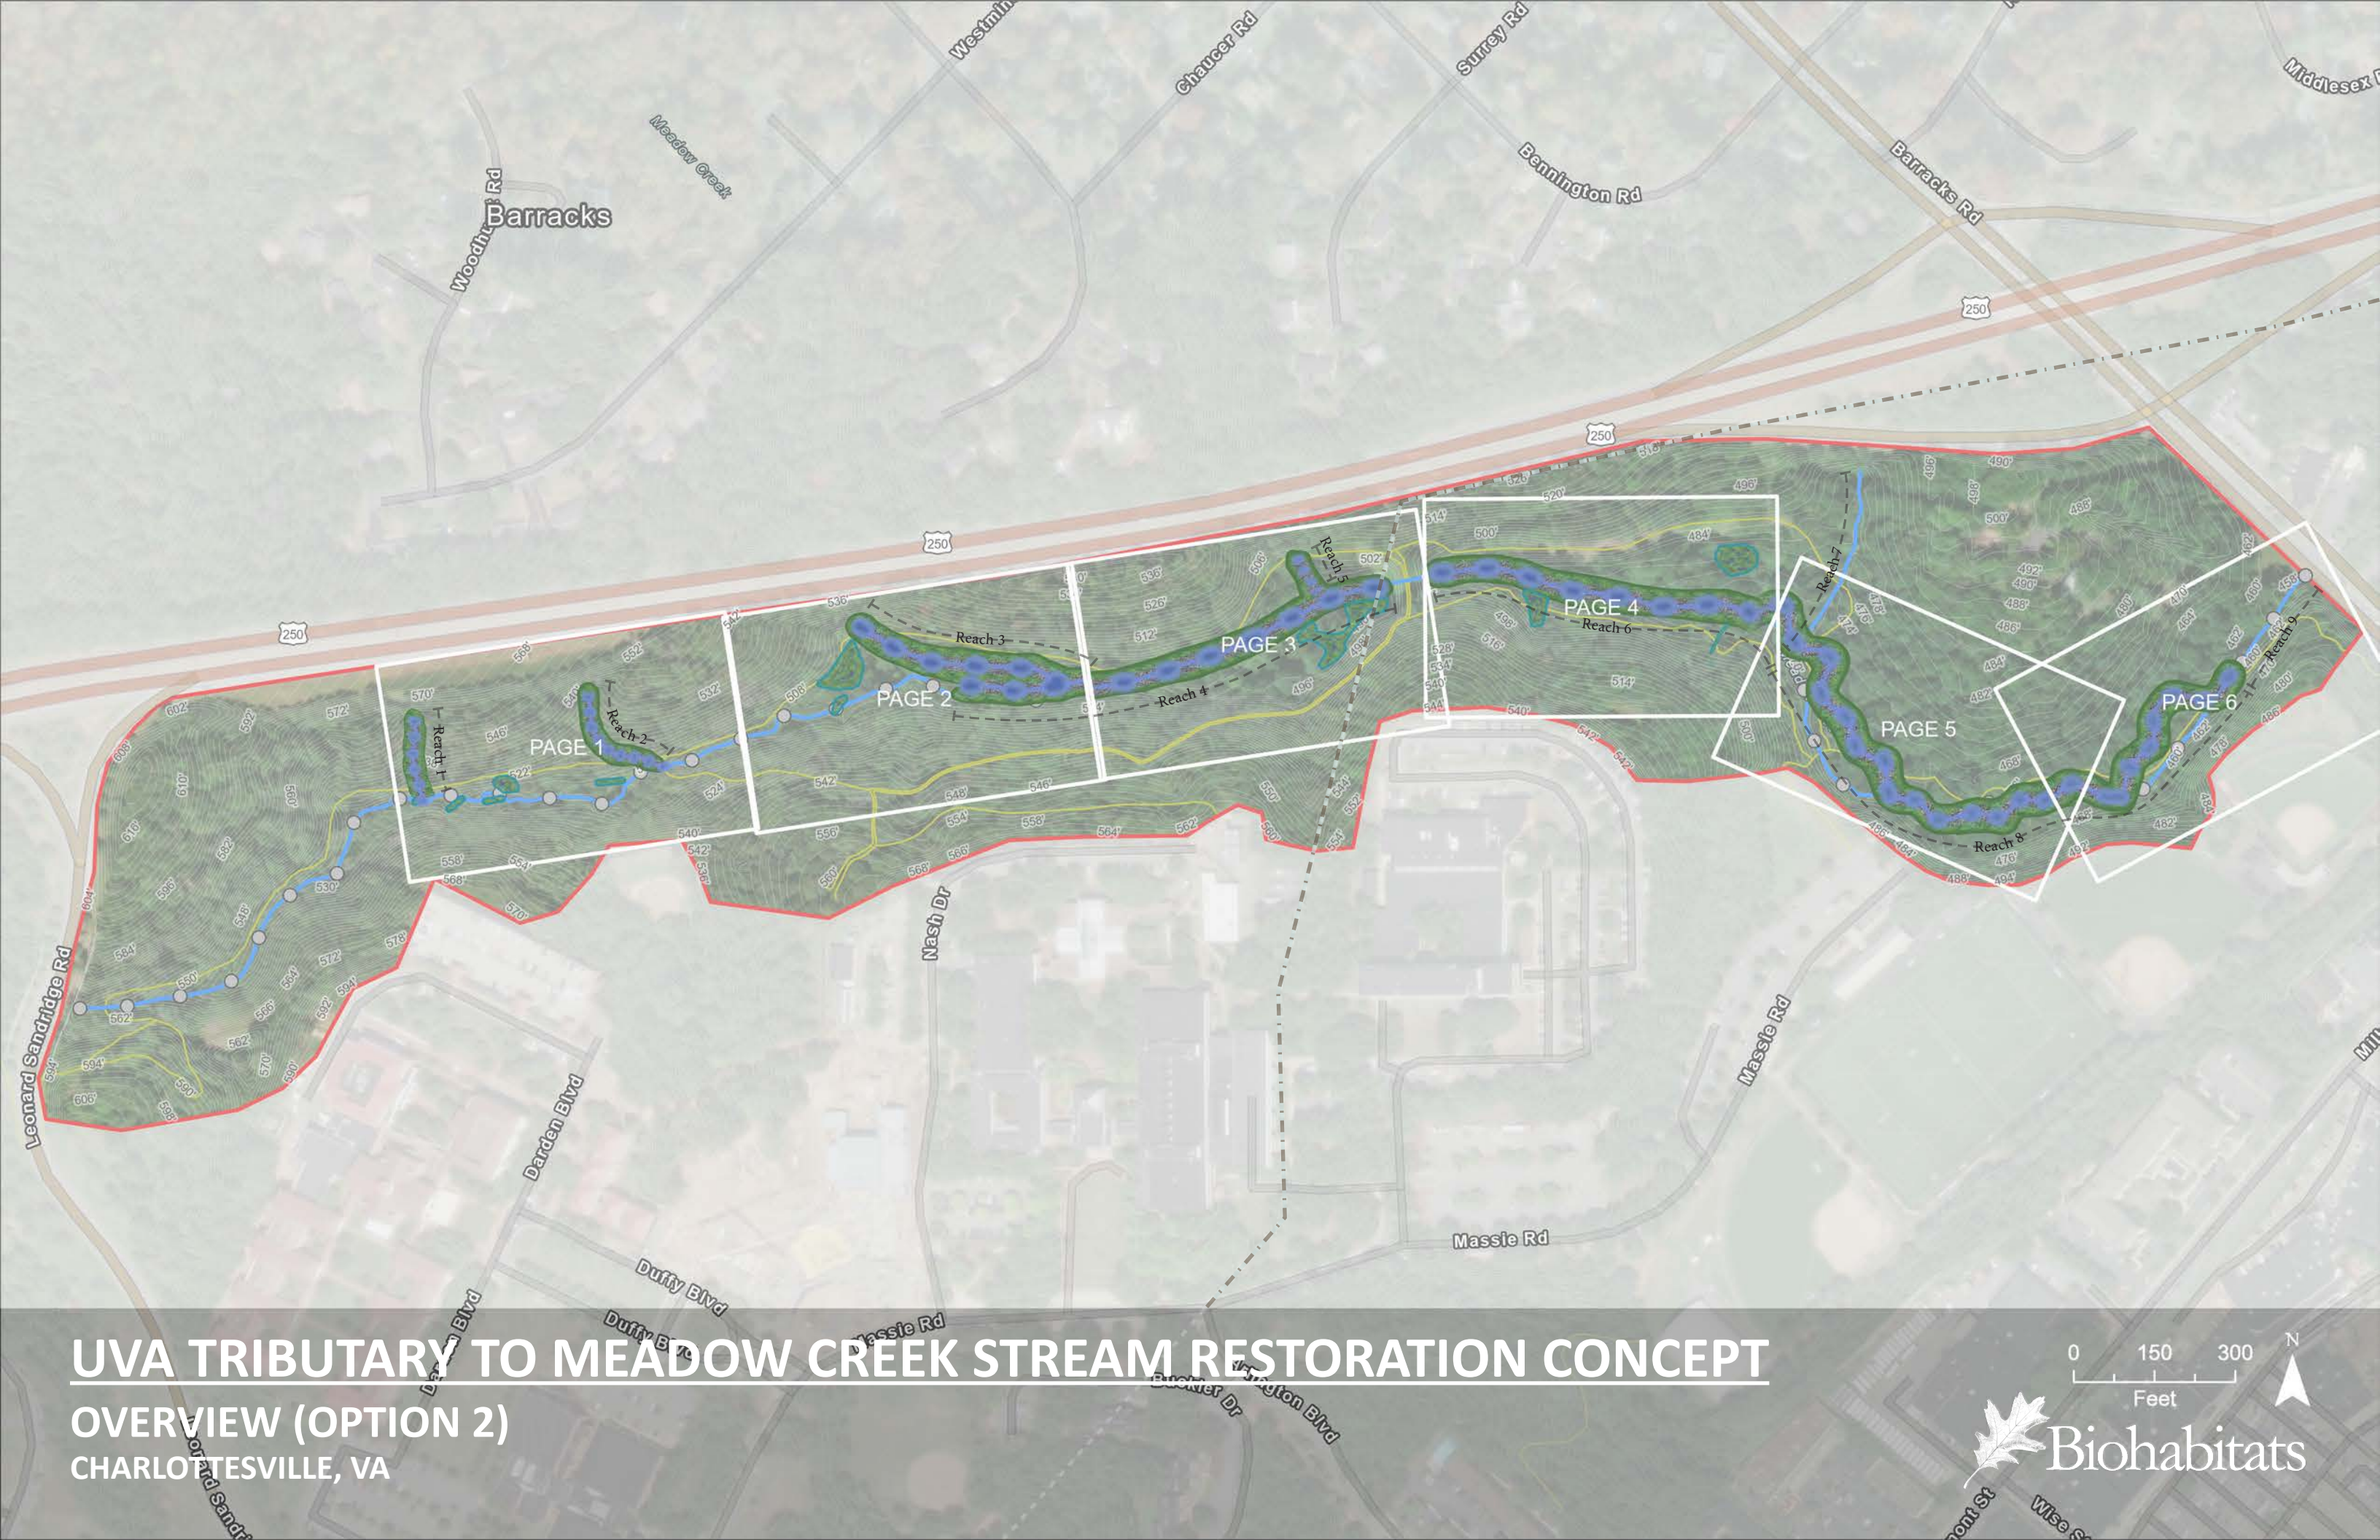
OVERVIEW (OPTION 2)
CHARLOTTESVILLE, VA

UVA TRIBUTARY TO MEADOW CREEK STREAM RESTORATION CONCEPT

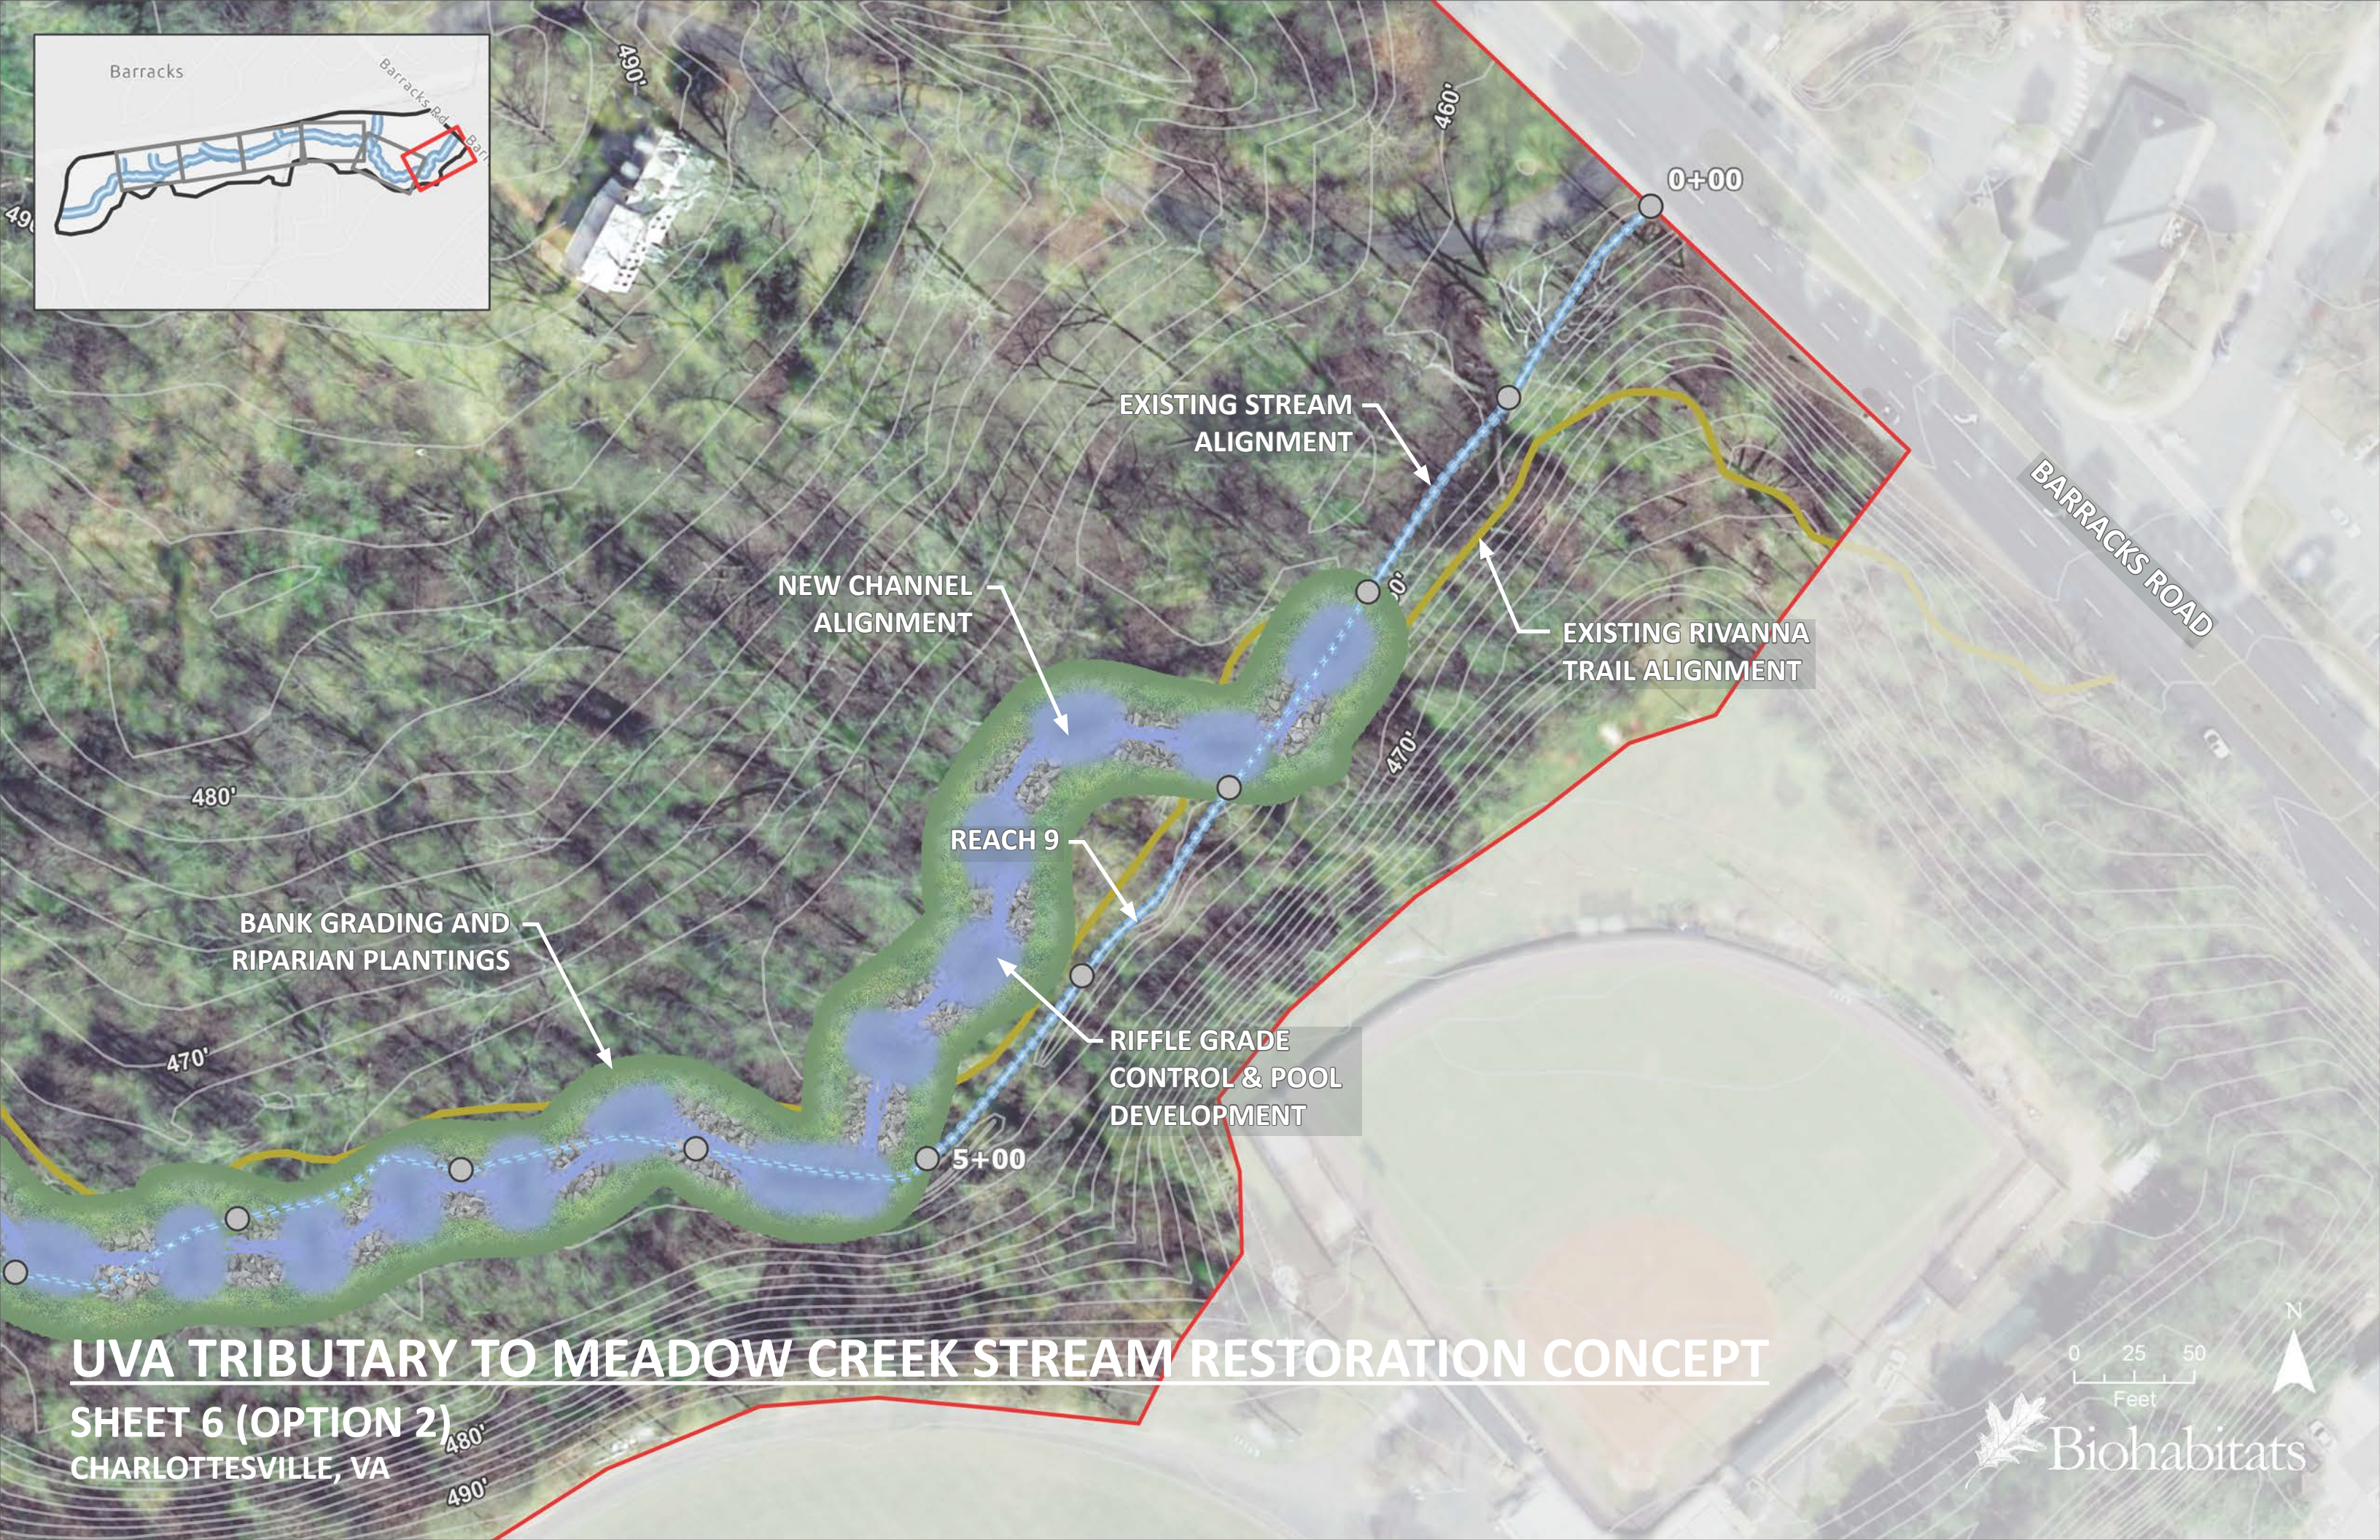
EXISTING STREAM
ALIGNMENT

NEW CHANNEL
ALIGNMENT

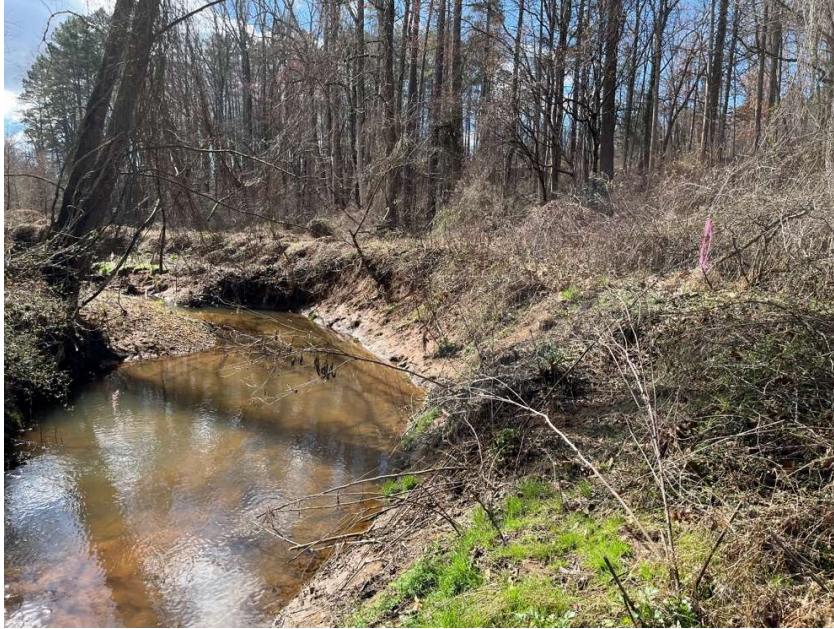
Figure 2 – Typical channel conditions in the Morey Creek study reach

During the 2024 field work it was evident that significant degradation of stream conditions had occurred since the 2019 assessment (See Figure 2). Field measurements were taken at several locations and eroded bank heights had increased by 1-ft on average and the BEHI rating increased to "High" and NBS rating increased to "Moderate". Collected sediment samples had an average bulk density of 74.2 lb/ft³, an average nitrogen concentration of 0.1%, and an average phosphorus concentration of 0.059%. Based on the new assessment and Protocol 1 calculation methods, it was estimated that stream restoration of this reach would result in 12,000 lbs/yr TSS, 23 lbs/yr TP, and 28 lbs/yr TN load reduction (Ches Bay TMDL).

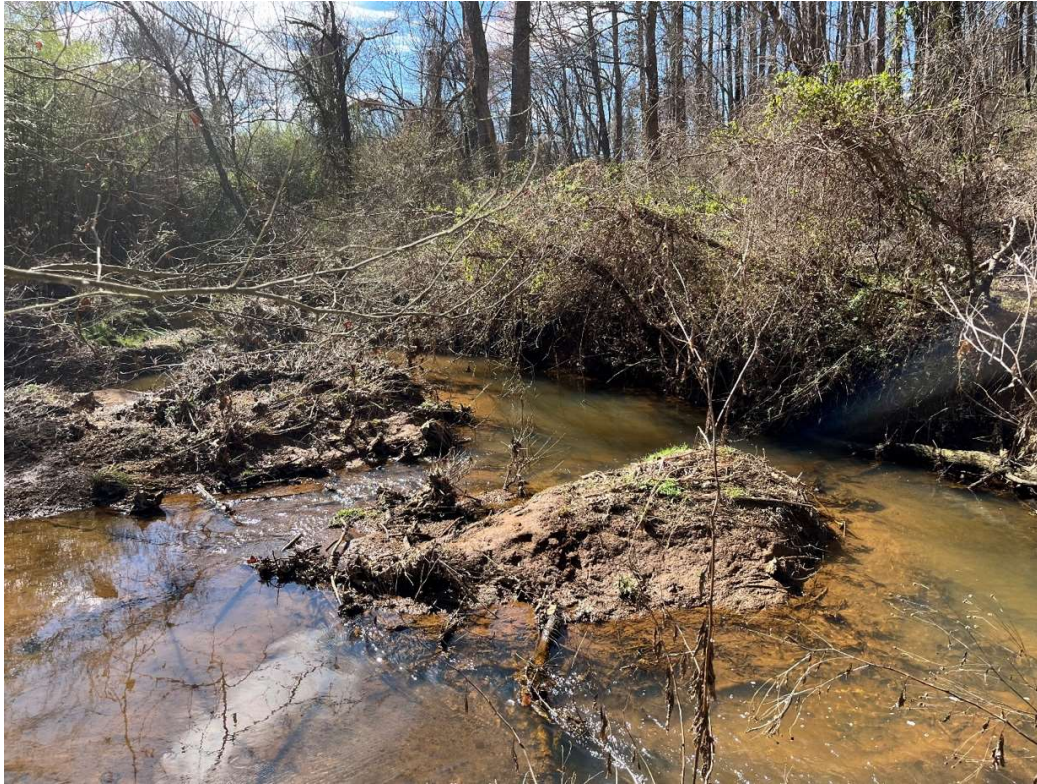
Figure 3 – Eroded bank sediments observed in the Morey Creek study reach

Two restoration concepts were developed for further consideration. The current stream is deeply incised with limited access to its floodplain. There is significant and ongoing erosion due to exposed near vertical banks and unstable plan geometry. The channel has down cut to a point where little vegetative, or root protection is provided in the streambanks, so bank soil rapidly erodes during high flow events. Figure 3 exemplifies the large-scale sedimentation due to bank failure within the channel.

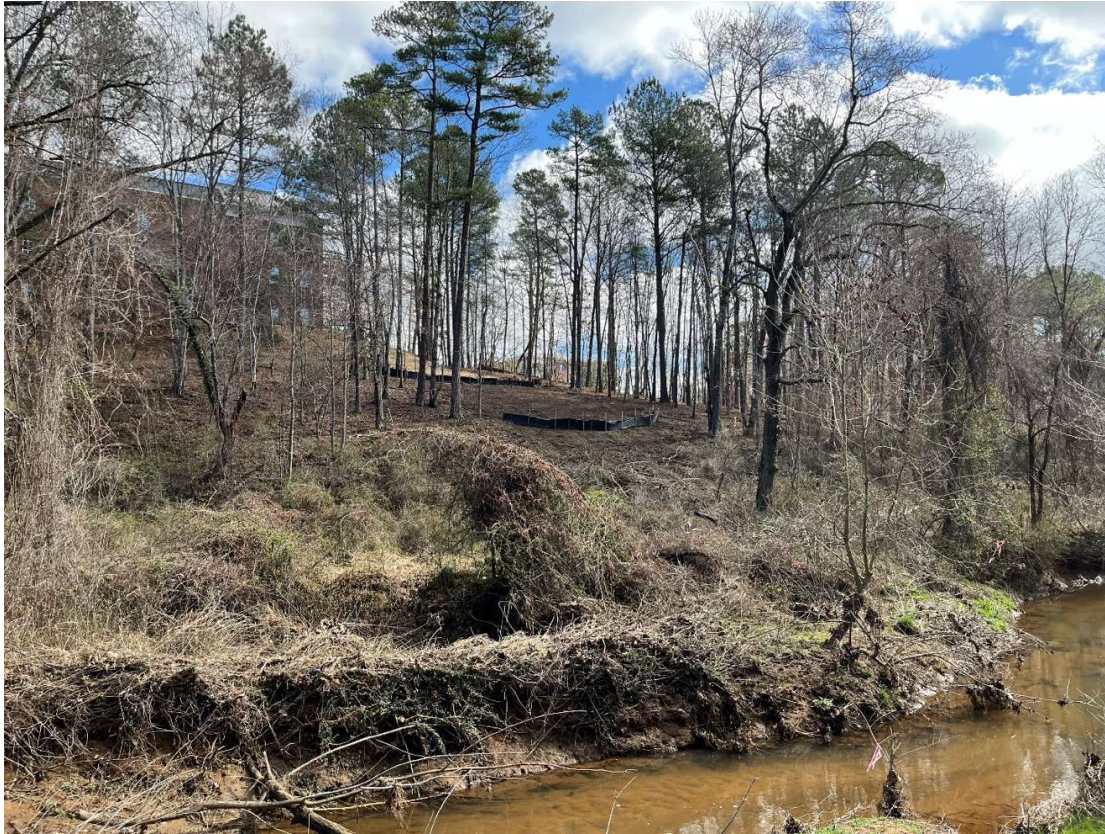
Figure 4 – Looking upslope toward the proposed sanitary sewer alignment and BMP expansion

The current design for the sewer proposes an aerial crossing of approximately 50 feet of stream valley from the base of the hillside to the north, then crossing Morey Creek at an elevation approximately two feet above the existing stream banks and connecting to a manhole with a rim elevation approximately four feet above existing grade. These infrastructure designs will need to be assessed with regard to the proposed stream restoration. Figure 4 shows the approximate location of the proposed sanitary line and BMP expansion.
