Moores Creek, Lodge Creek, Meadow Creek, and Schenks Branch Sediment Total Maximum Daily Load (TMDL) Action Plan Permit Cycle: 2018-2023

General Permit No.: VAR040073

April 30, 2021

Prepared by:
University of Virginia
Facilities Management, Environmental Resources Division
1490 Leake Drive, Charlottesville, VA 22904
(434) 243-5380

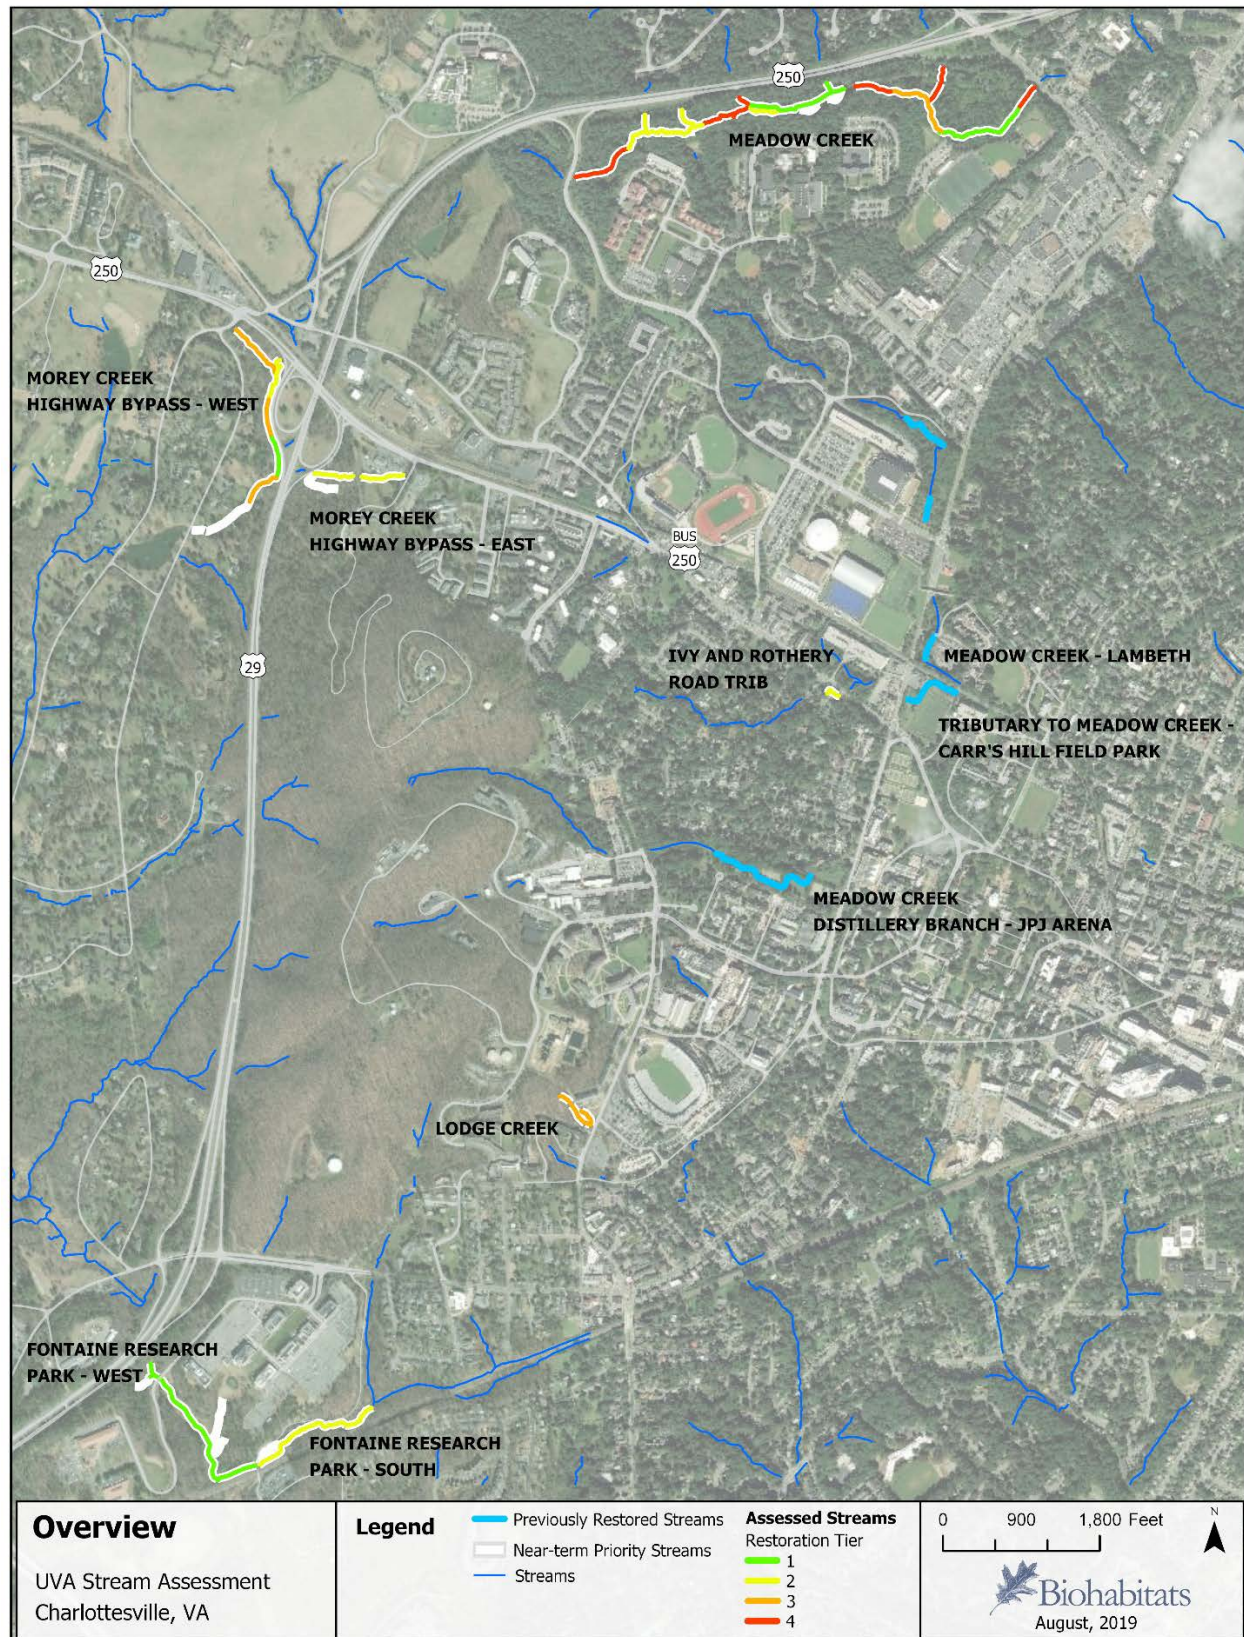
Figure 1. UVA Stream Assessment Locator Map

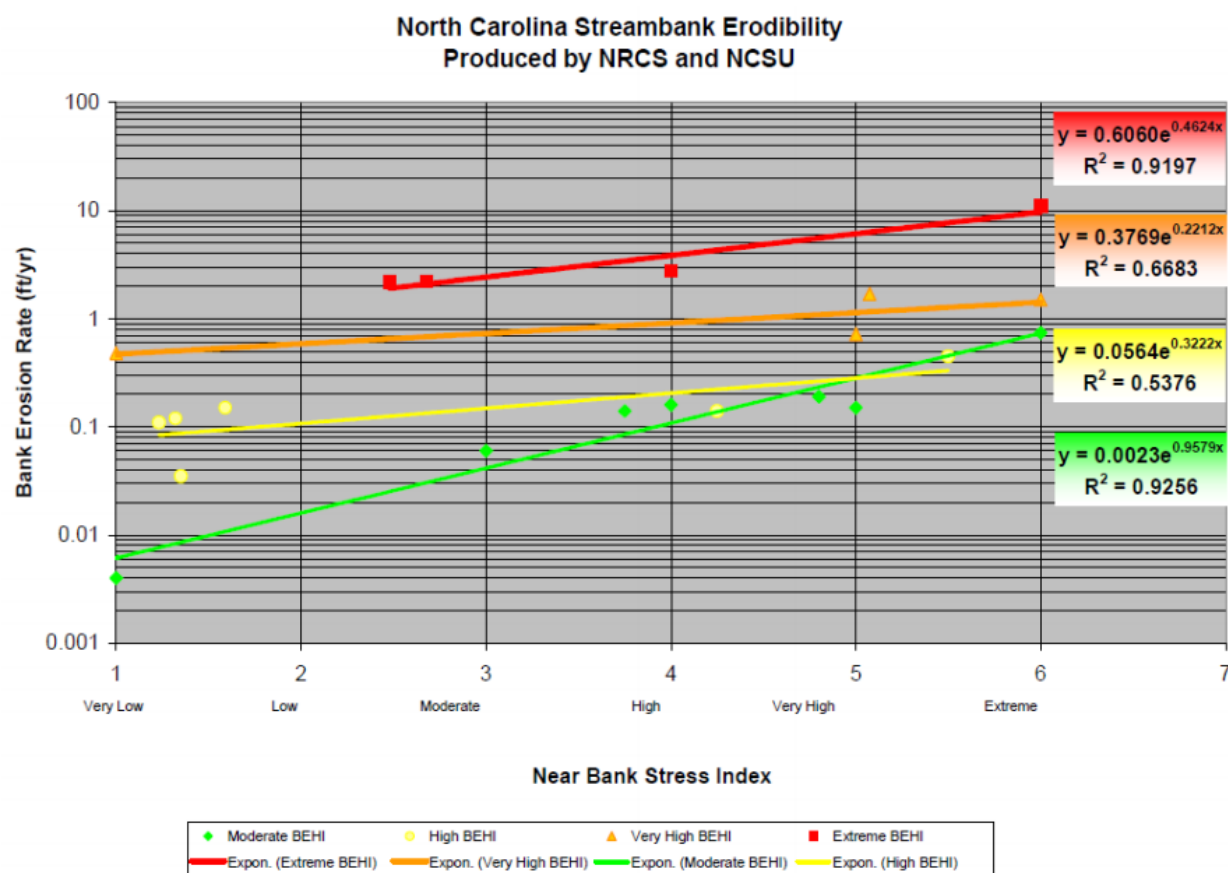
Figure 2. North Carolina Piedmont Region Bank Erosion Prediction Curve

As part of the nutrient and sediment reduction calculations for stream restoration projects using Protocol 1, the average BEHI and NBS ratings for each stream reach were converted to bank erosion rates using the North Carolina Piedmont Region Bank Erosion Prediction Curve (North Carolina State University Stream Restoration Program, 1989) (**Figure 2**). Due to similarities in site conditions, the North Carolina Piedmont Region Bank Erosion Prediction Curve was used over other regional curves including South Central Colorado, which has steep slopes and Hickey Run in Washington, DC, which has a high level of impervious cover.

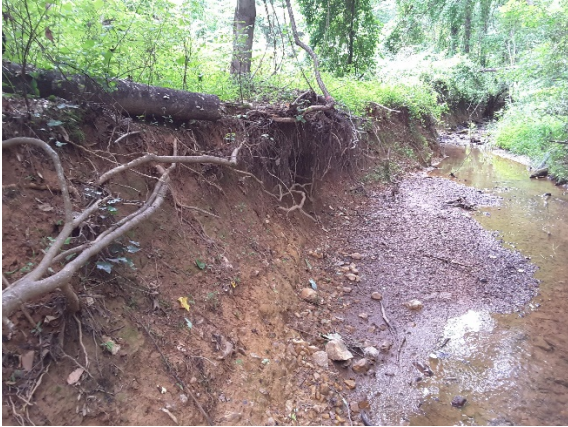
MDC-006

Figure 3. Photos Depicting Top 6 Ranked Stream Conditions

This portion of Meadow Creek runs between US 29 and the Law School Student Faculty Center. It has an average of four foot high banks and is more than 700 feet in length. The BEHI rating is high and active erosion was rated as severe. The surrounding riparian corridor is forested and in good condition. This project may be combined with the RSC, MDC-006-RSC-001.
