# **Rivanna River Combined Benthic and Bacteria Total Maximum Daily Load (TMDL) Action Plan Update Permit Cycle: 2018-2023**

General Permit No.: VAR040073

May 1, 2020

Prepared by:  
University of Virginia  
Facilities Management, Environmental Resources Division  
1490 Leake Drive, Charlottesville, VA 22904  
(434) 243-5380

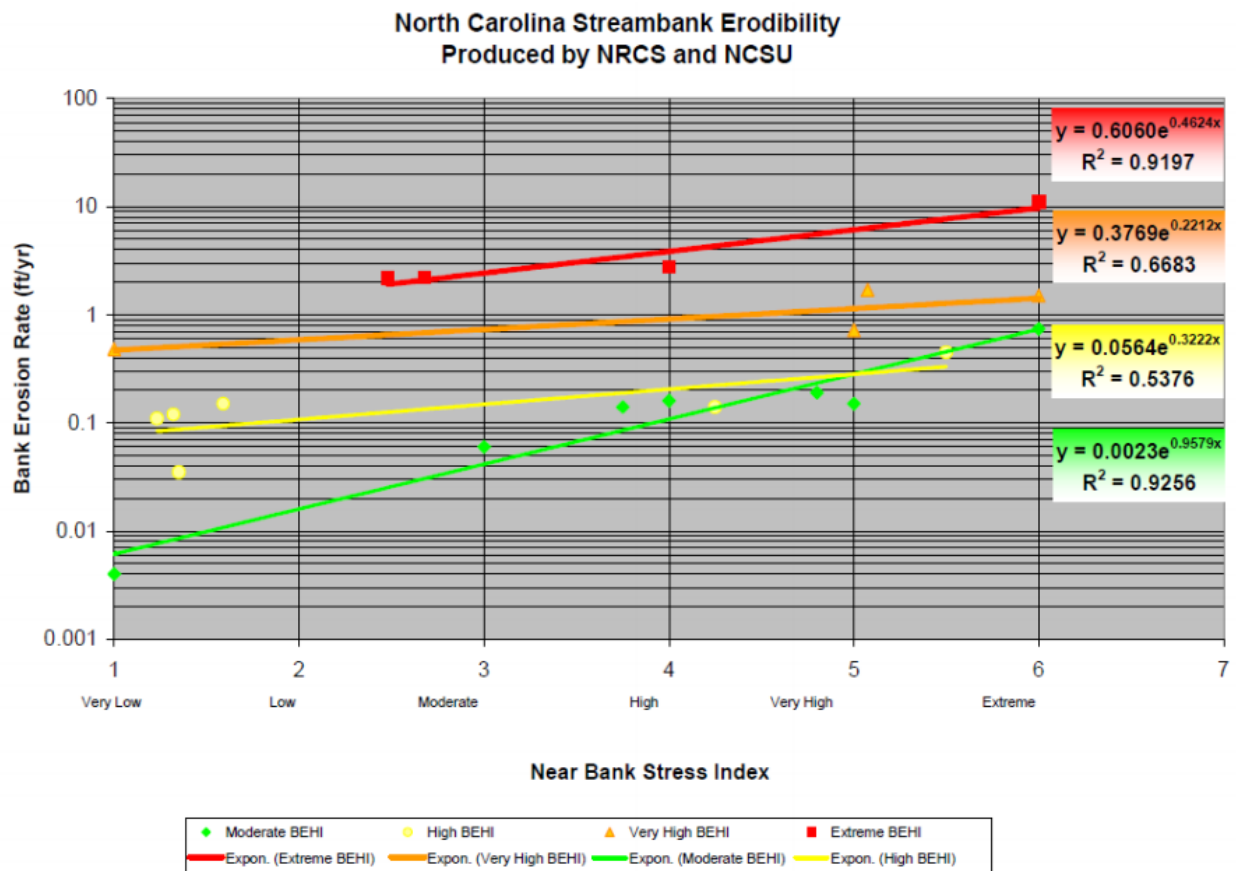
**Figure 2. North Carolina Piedmont Region Bank Erosion Prediction Curve**

As part of the nutrient and sediment reduction calculations for stream restoration projects using Protocol 1, the average BEHI and NBS ratings for each stream reach were converted to bank erosion rates using the North Carolina Piedmont Region Bank Erosion Prediction Curve (North Carolina State University Stream Restoration Program, 1989) (**Figure 2**). Due to similarities in site conditions, the North Carolina Piedmont Region Bank Erosion Prediction Curve was used over other regional curves including South Central Colorado, which has steep slopes and Hickey Run in Washington, DC, which has a high level of impervious cover.

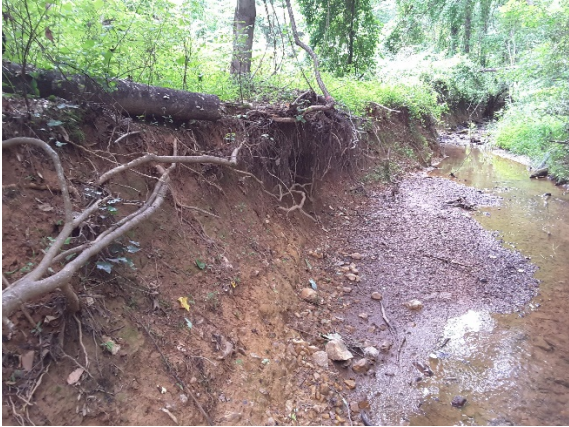
MDC-006

Figure 3. Photos Depicting Top 6 Ranked Stream Conditions

This portion of Meadow Creek runs between US 29 and the Law School Student Faculty Center. It has an average of four foot high banks and is more than 700 feet in length. The BEHI rating is high and active erosion was rated as severe. The surrounding riparian corridor is forested and in good condition. This project may be combined with the RSC, MDC-006-RSC-001.

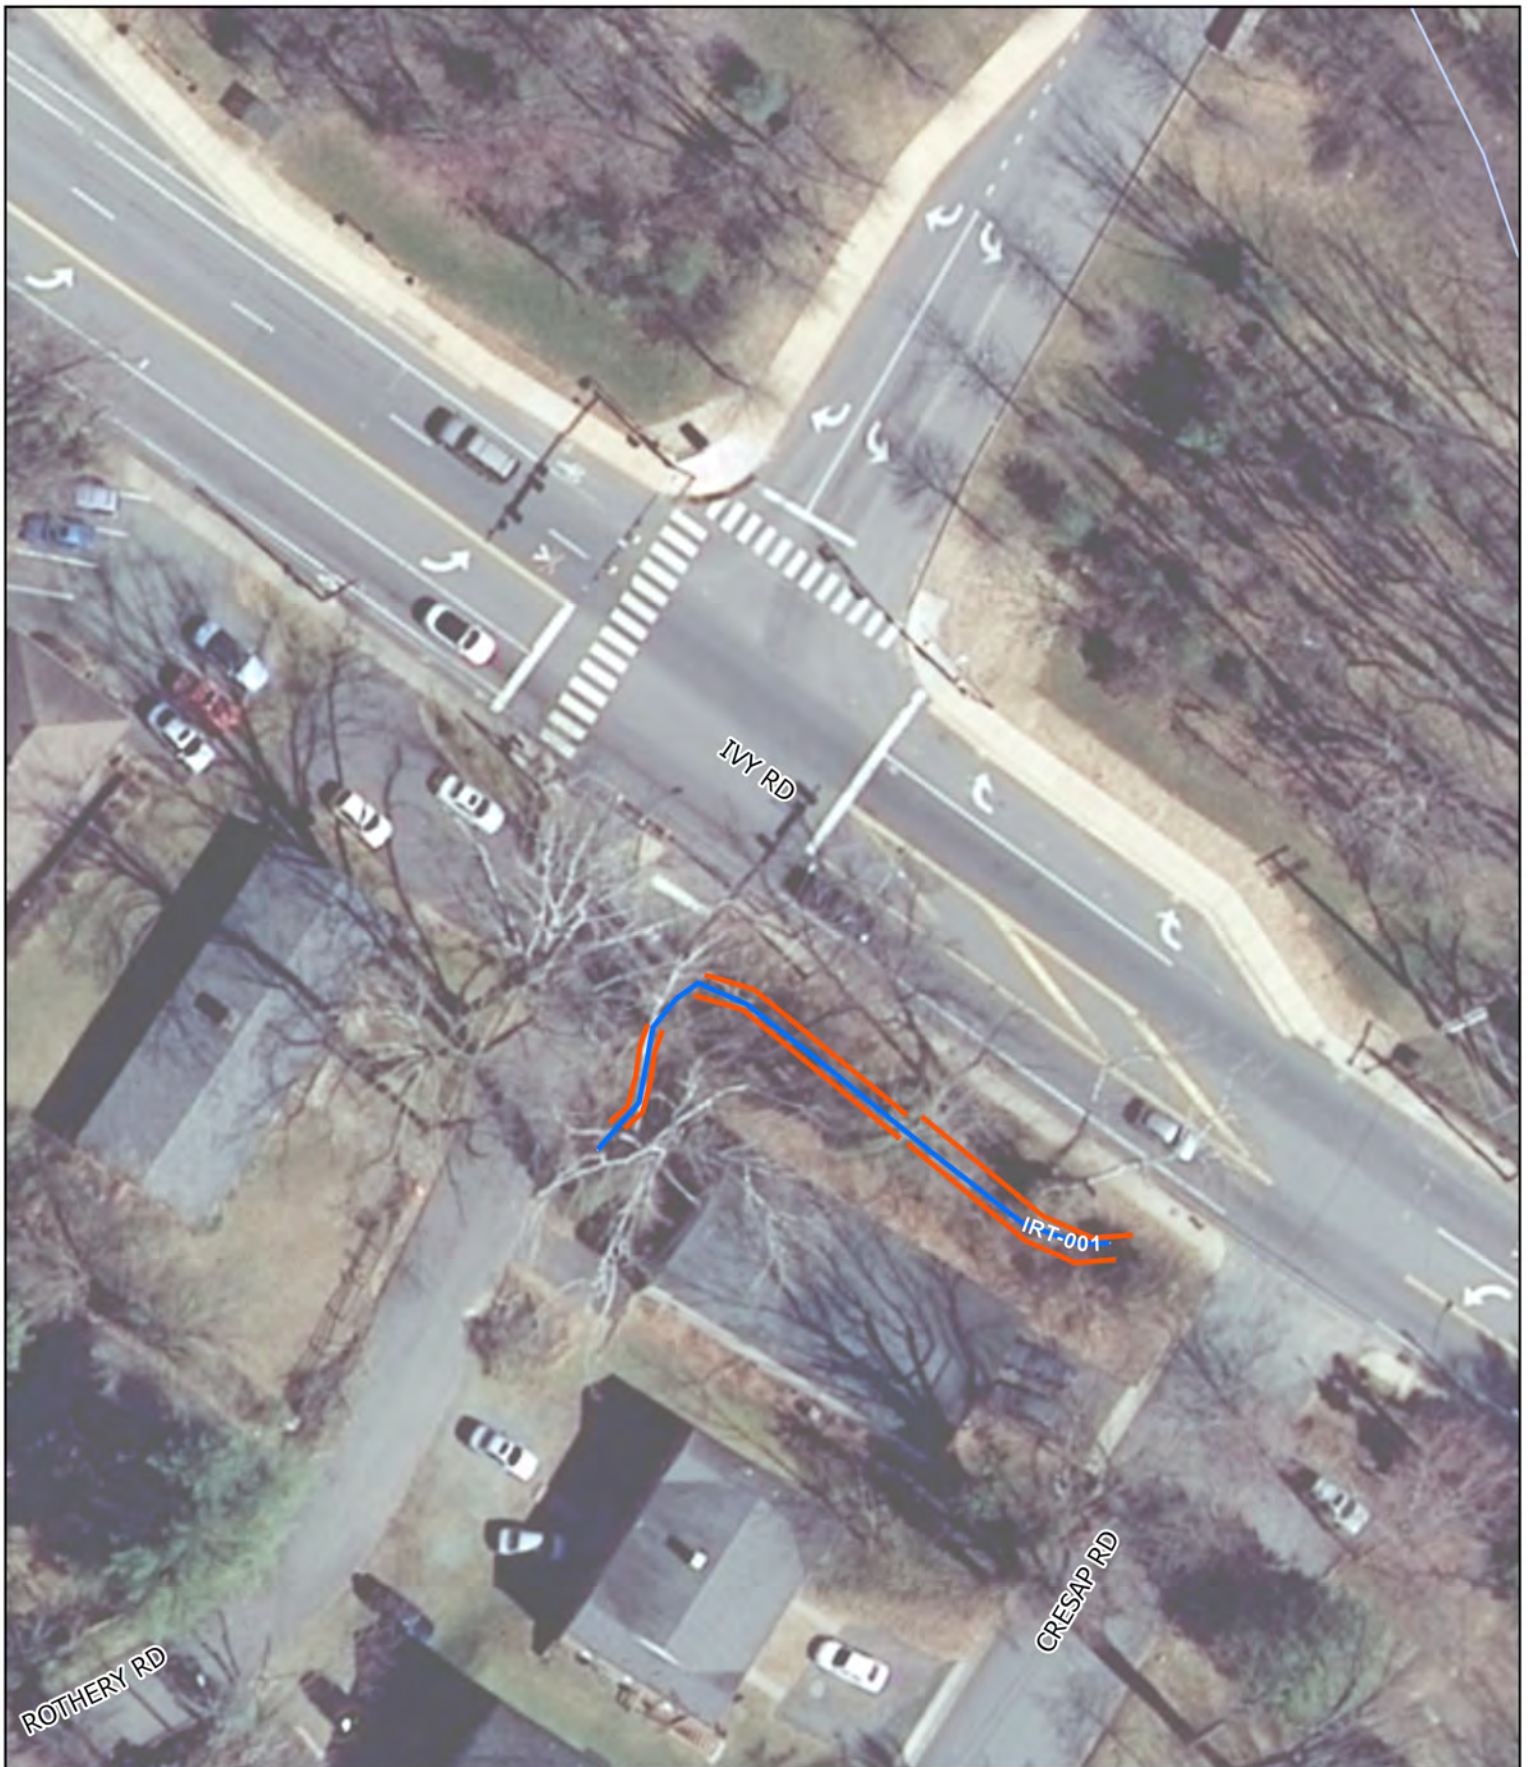
## Ivy and Rothery Road Trib

UVA Stream Assessment  
Charlottesville, VA

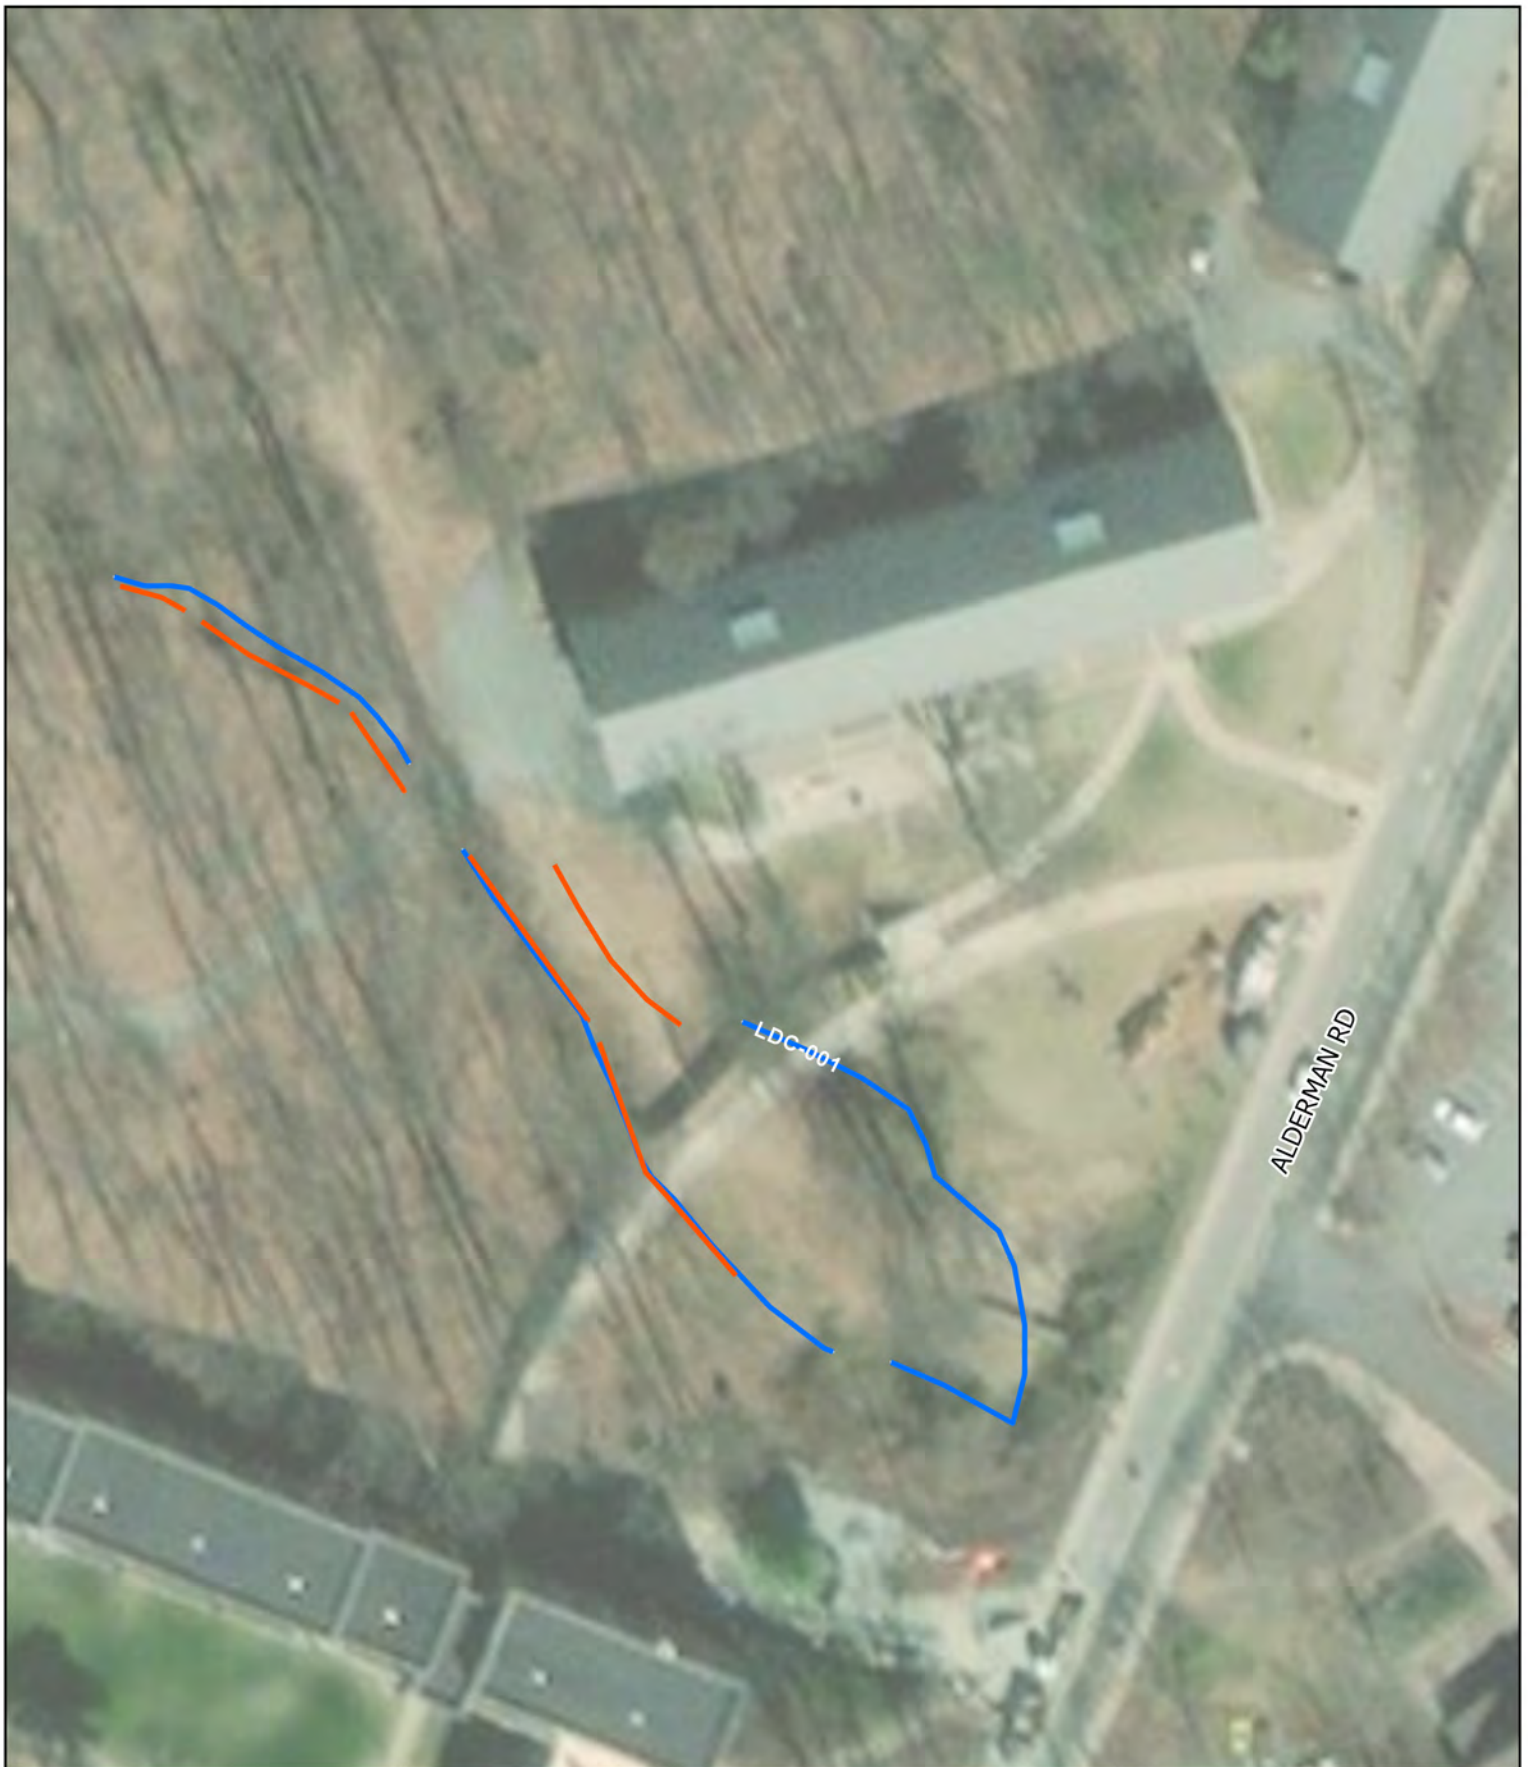
## Lodge Creek

UVA Stream Assessment  
Charlottesville, VA

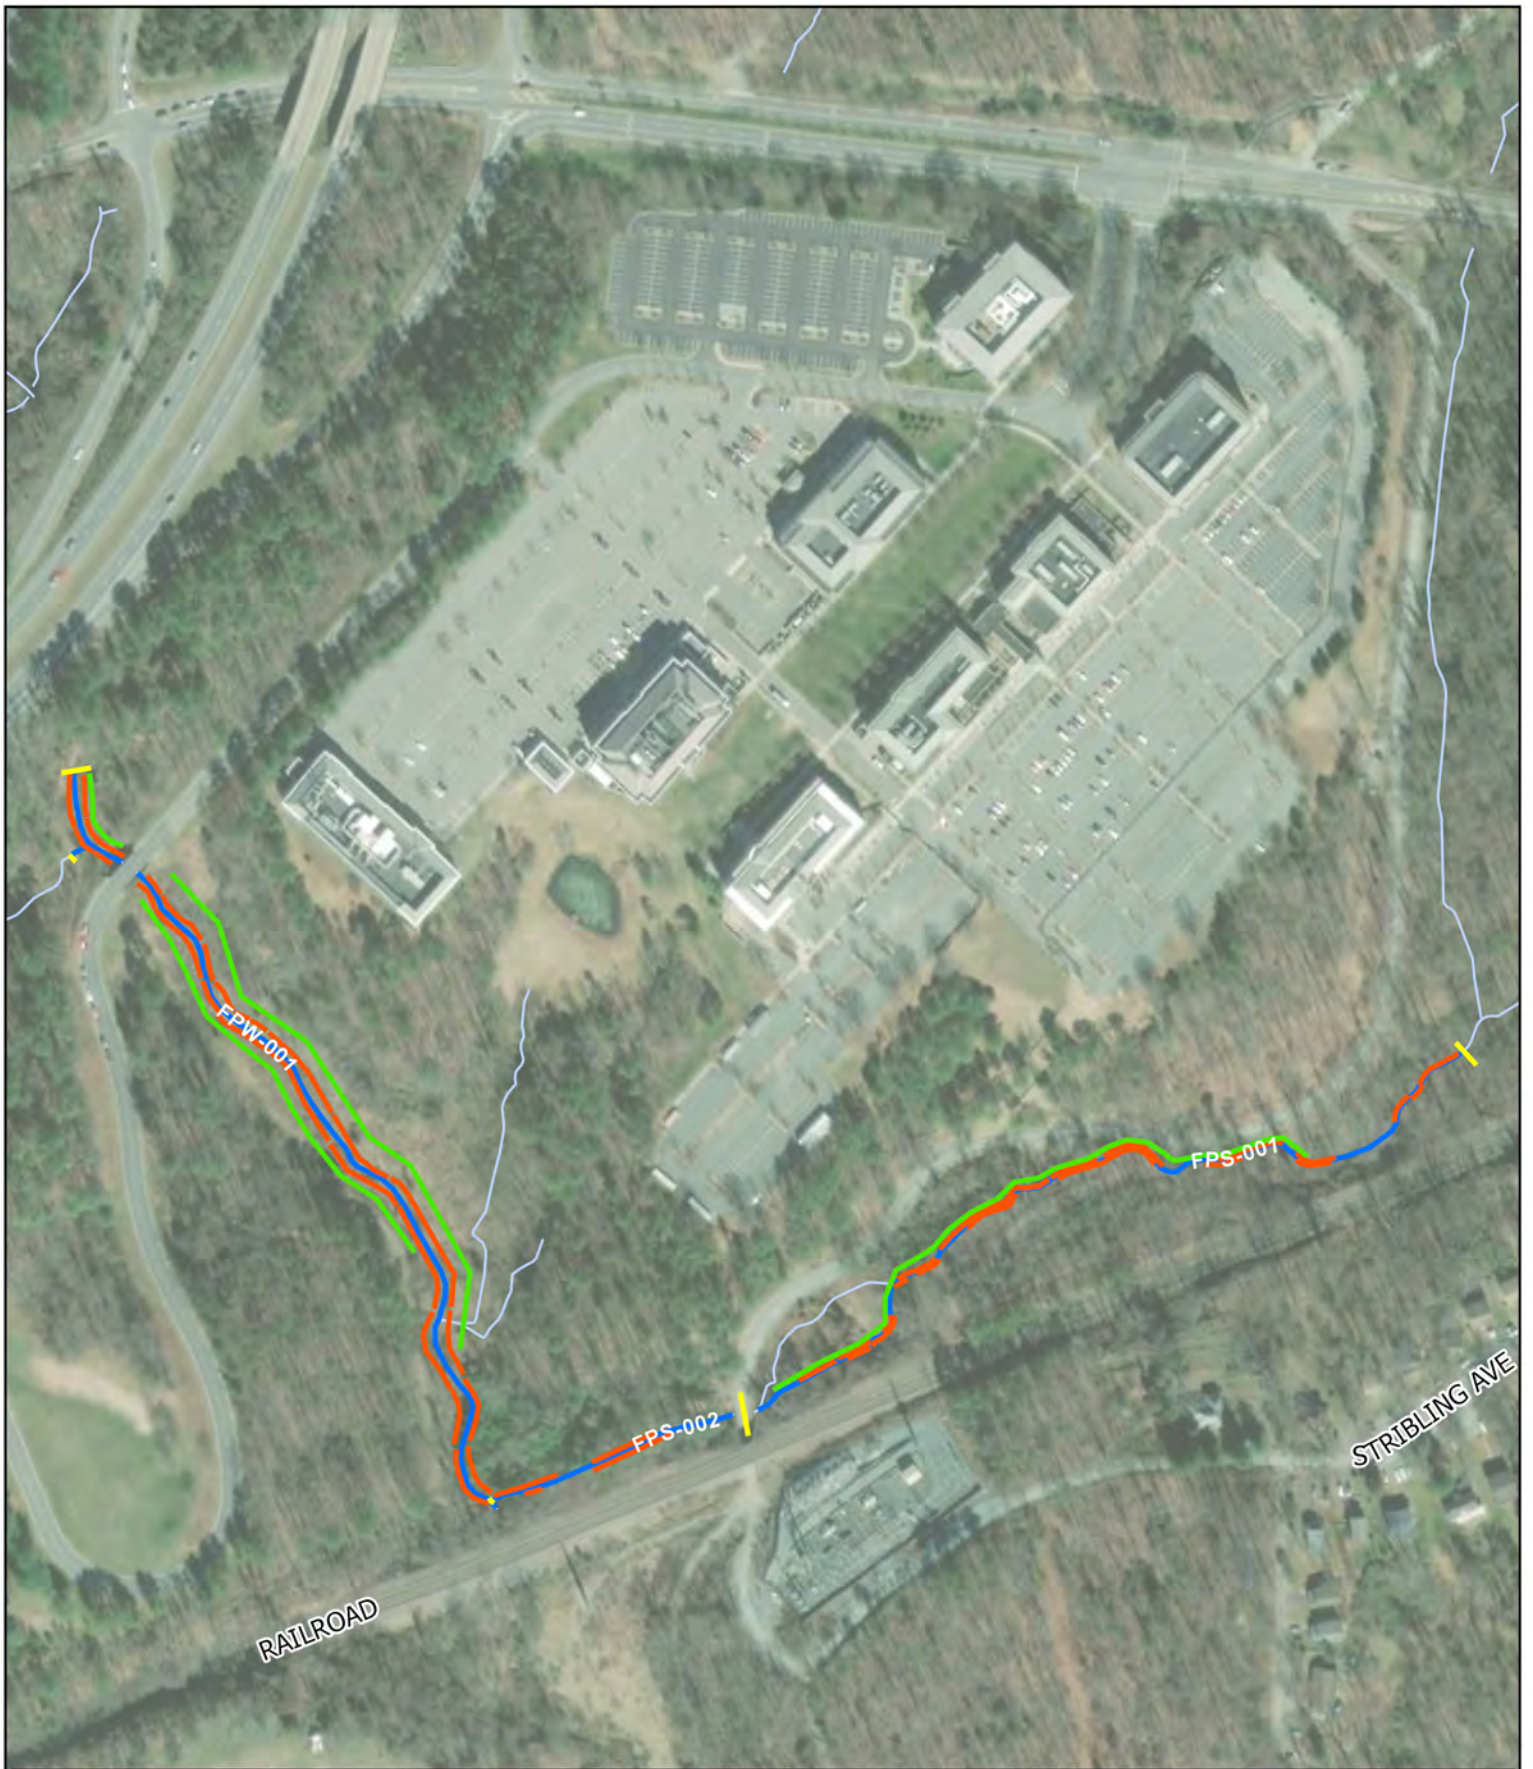
## Fontaine Research Park

UVA Stream Assessment  
Charlottesville, VA
